Town of Bow Fire Station/Community Building Electrical Assessment
October 7, 2013

YEATON ASSOCIATES, INC.

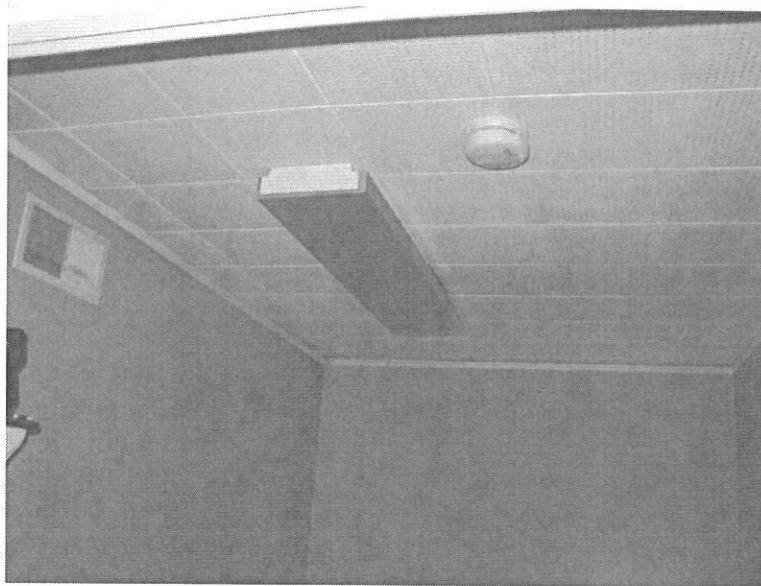
Currently, there are single-station smoke alarms in the Fire Department's sleeping quarter's area. There is no central fire alarm system. The Town is currently reviewing the location of sleeping quarters to allow for direct exterior egress.

Single Station Alarm(s) in Sleeping Quarters

2. Egress Lighting: Bring egress and exit lighting up to NFPA 101 (Life Safety Code) standards, including egress and exit lighting from basement.
3. Fire Alarm: We recommend a fire alarm system for any fire station with sleeping quarters.

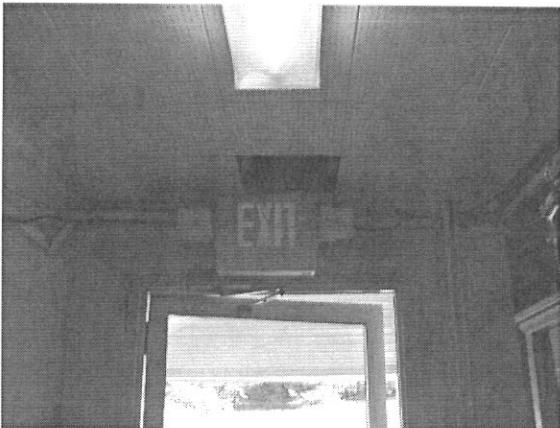
Facility exit signs are green LED and provide reasonable direction in paths of egress. Most exit signs are unit battery equipment. The battery packs in these units passed the push-to-test procedure. One exception was the second floor meeting room exit sign, which failed this test.

Combination Egress and Exit Lighting Unit

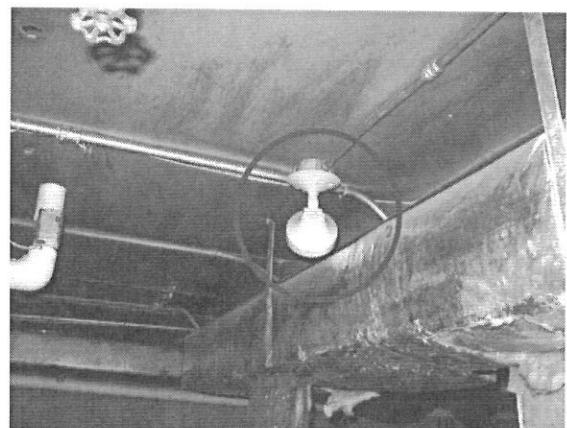
Egress lighting is provided by either stand-alone units or combination (exit and egress lighting) units. Egress lighting coverage does not meet code (NFPA 101 Life Safety) requirements for coverage. As an example, there is a single emergency fixture in the basement which is non-operational. The egress path (stairs) should be covered with an average of 1 foot candle of egress lighting.

Non-operational Remote Emergency Lighting Unit in Basement

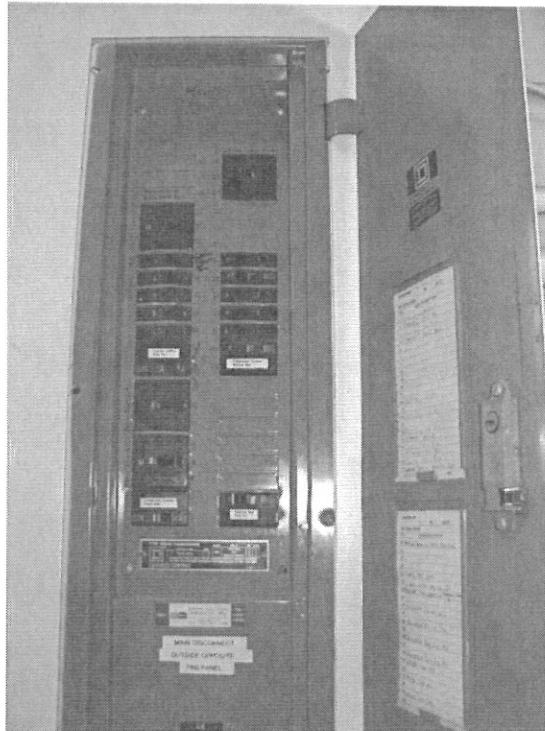
The Main Panel is manufactured by Square D, and has additional breaker space available. The panel is located in the vehicle bay in the northeast corner of the fire station. The panel has no signs of overheating or water damage. The panel has a directory of the circuits and the current electrical contractor has added/verified circuit information as they have worked on the building.

Building Main Panel

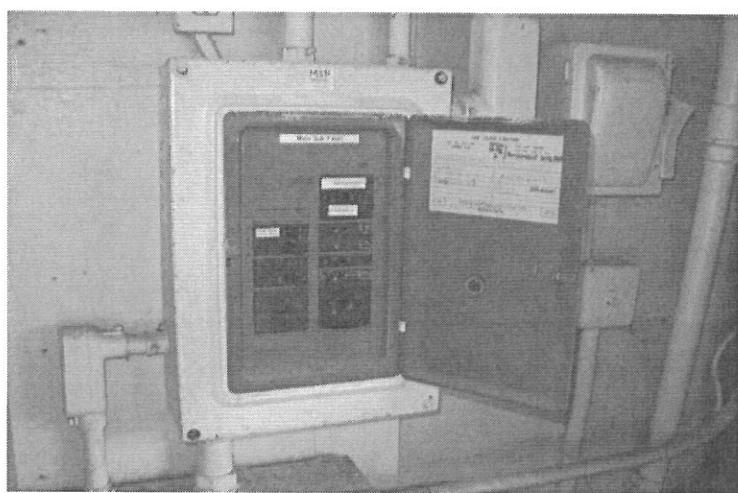
The (9) load center sub-panels are a mixture of manufacturers. Half of the sub-panels are full of breakers and there is also use of tandem breakers to add circuits. The observed manufacturers' labeling did not indicate that tandem breaker use was acceptable. Panels must be listed and labeled for the use of tandem breakers in order to be code compliant.

Sub-panel located in Vehicle Bay (Representative of a typical load center)

- b. Bond both ends of the galvanized steel (ferrous) conduit encasing grounding electrode conductors.
5. Branch Panels (load centers):
 - a. Provide additional sub-panels or consolidate circuits to eliminate tandem breakers on load centers that are not listed and labeled for tandem breaker use.

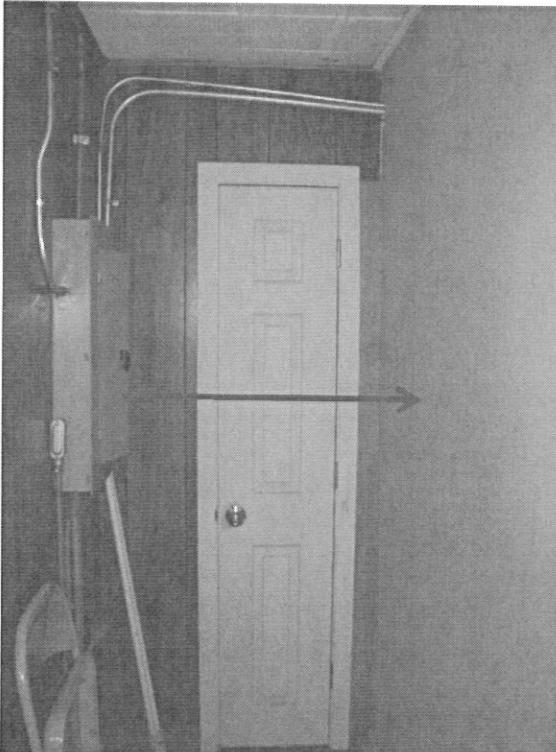
Many sub-panels did not have the required 3 feet of working clearances in front. Most of the encroachments into the working clearances were from stored materials or moveable work tables/cabinetry. The "Kitchen Sub-Panel" has building structure that reduces the working clearance below code minimum requirements.

Kitchen Sub-Panel Working Clearance Less Than Code

- b. Provide filler plates as required.
 - c. Provide proper working clearances in front of panels by removing storage or portable furnishings. Relocate panels or modify building structure where clearances are compromised by building structure.

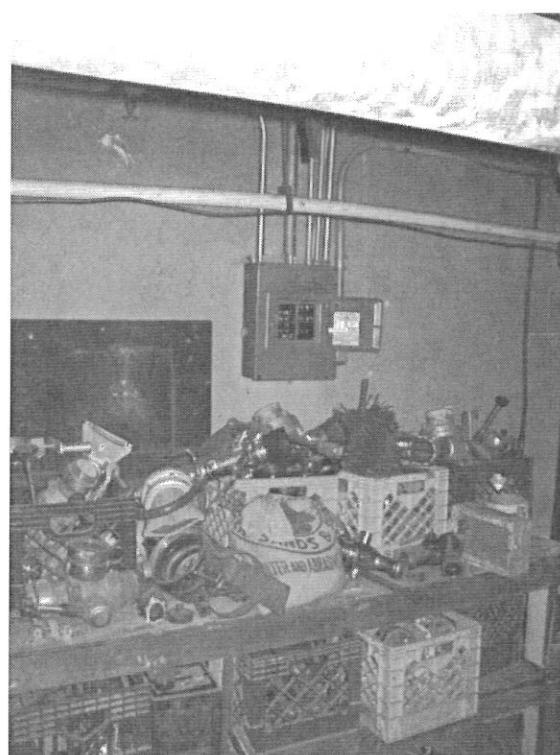
Basement Load Center with Storage/Movable Cabinetry
Encroaching into Working Clearances

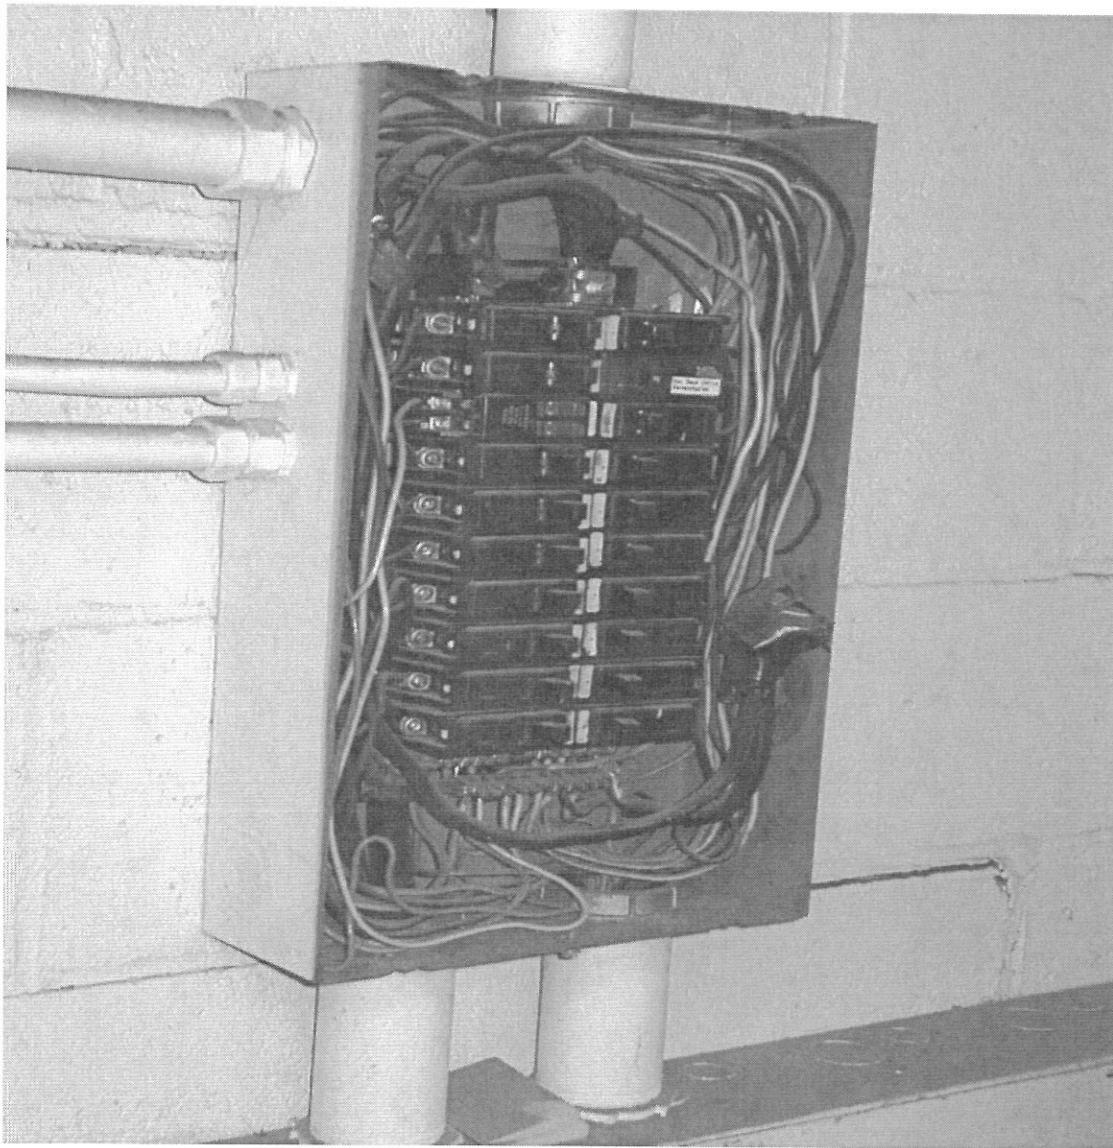
- The branch circuit wiring was predominately THHN/THWN and in good condition. No damaged insulation was observed.
- Neutral bars were used for both neutral wire connections and ground wire connections. Grounding conductor connections to neutral bars in sub-panels is a code violation (the only bonding of neutral and ground is allowed at the service entrance). Additional discussion can be found under "Grounding" below.

Load Center Interior

- d. Add ground bars, relocate grounding conductors to ground bars and remove bonding jumpers to isolate equipment grounding system from the system neutrals.

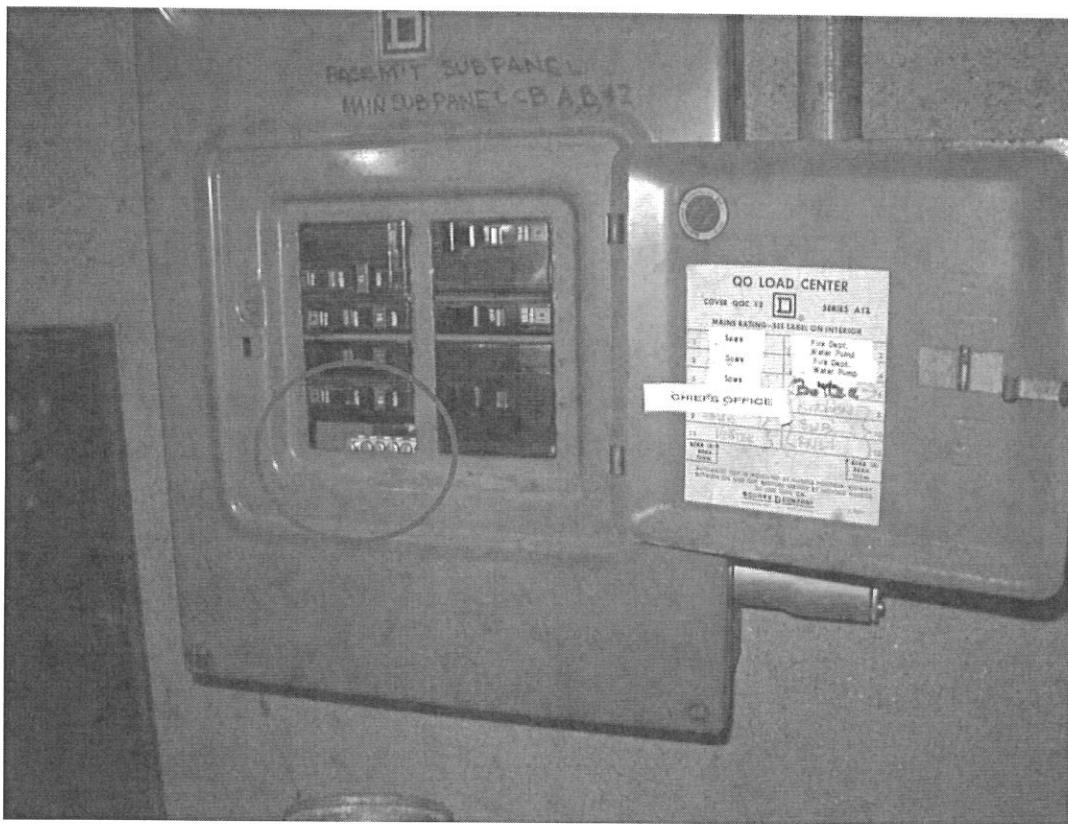
One load center was observed with a blank opening (which exposes live parts) and must have a filler plate installed.

Load Center in Need of Filler Plate

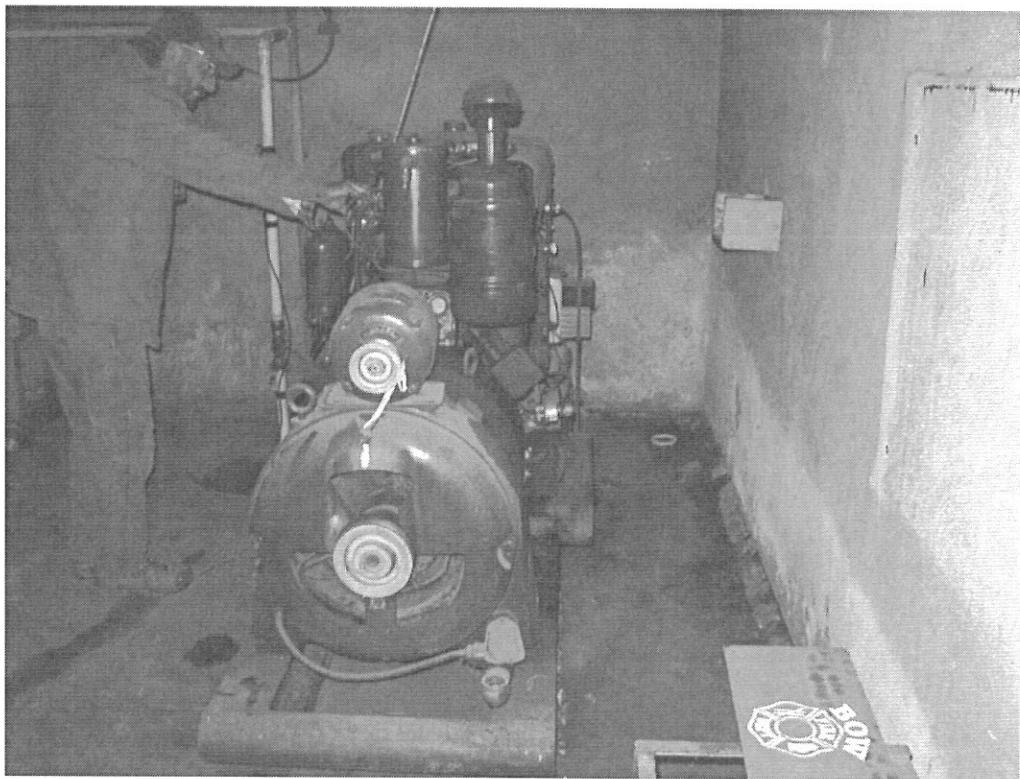
There is an abandoned generator set in the basement that should be removed.

Abandoned Generator in Basement

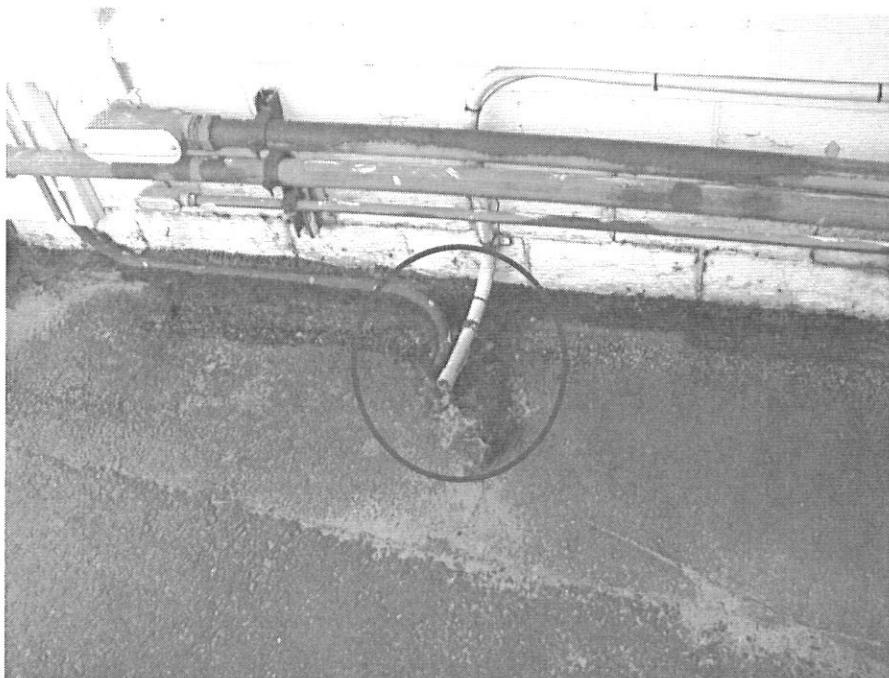
The service has a single ground rod and is bonded to the building steel. The grounding electrode conductor is in a metal conduit. There is no evidence that the water service entrance grounding electrode is connected.

Current code requires metal conduit that encloses grounding electrode conductors to be bonded at each end to the grounding electrode conductors.

Service Ground Rod

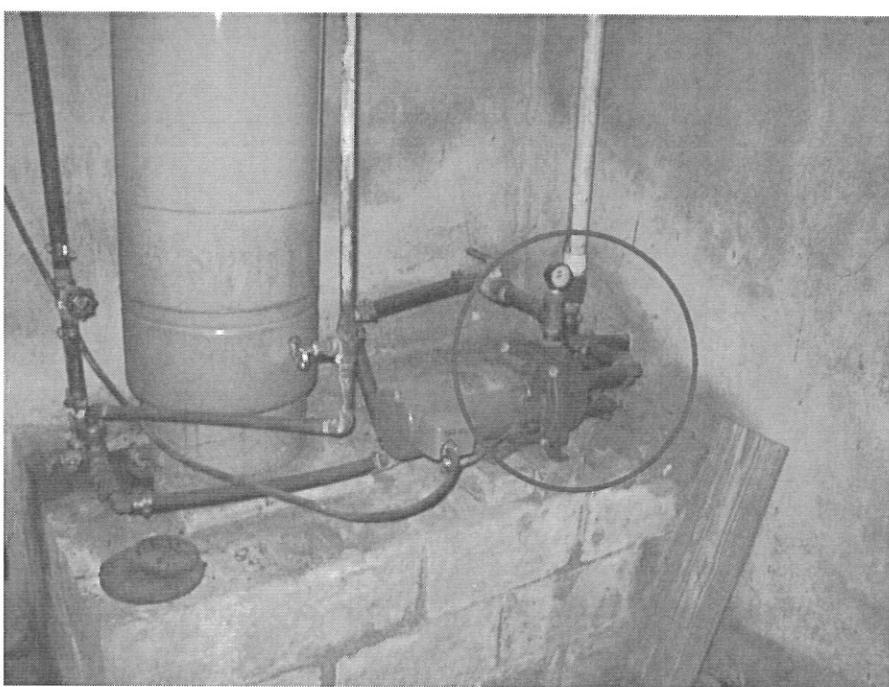
Water Service Entrance

4. Electrical Service Grounding:
 - a. Provide grounding electrode conductor to the metallic water service pipe and provide continuity around booster pump and any other item that may be removed for service.

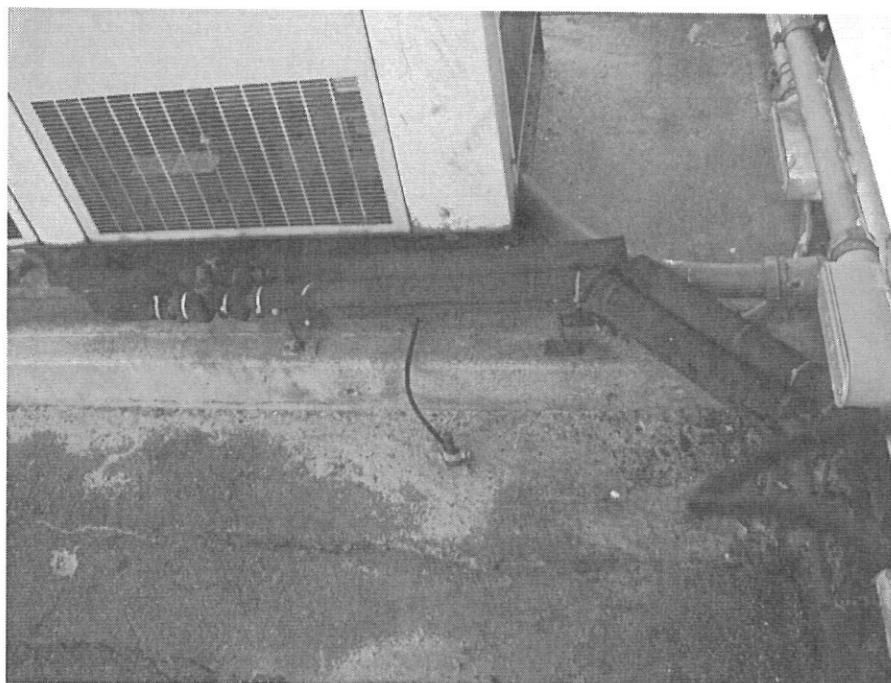
The generator ground rod is required by the manufacturer, and grounds the frame only.

Generator Ground Rod

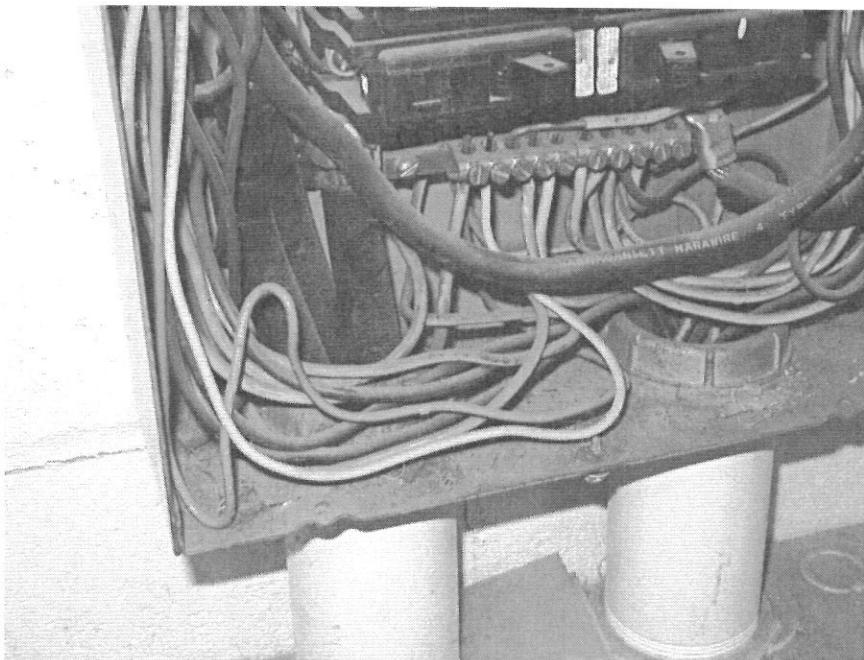
There can only be one neutral to ground bonding jumper in a system. Each load center will need to have a ground bar and a separate neutral bar. Any bonding jumper in those neutral bars has to be removed.

Load Center with Ground Conductor on Neutral Bar

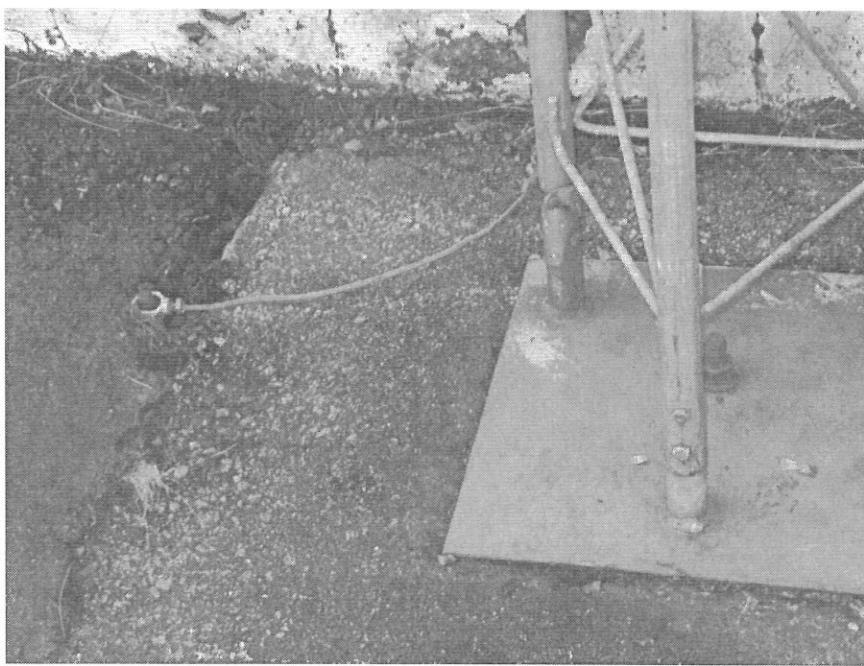
The radio tower is a separate structure and the ground rod for the radio tower is not required to be bonded to the building grounding electrode system.

Radio Tower Grounding

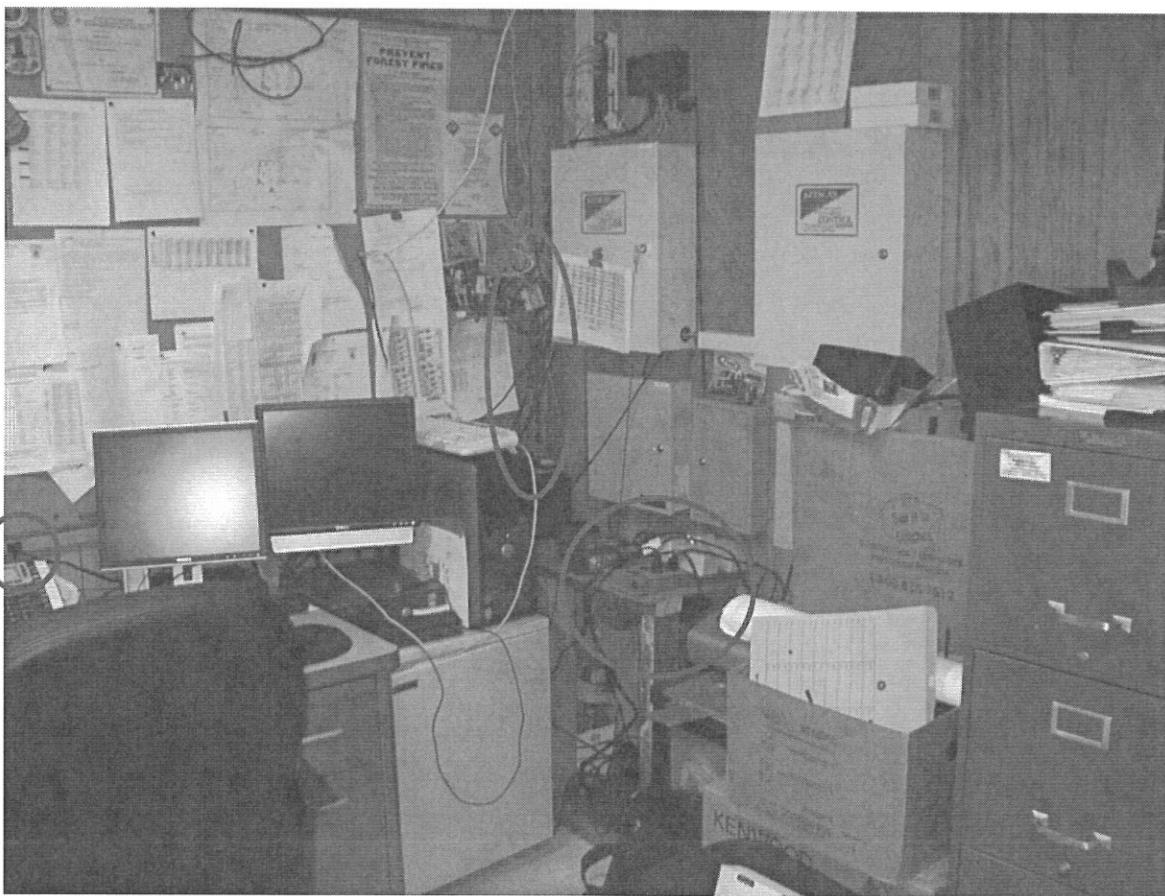
The facility is not experiencing overload branch circuits (breakers tripping). However, there are areas where there are not enough outlets to serve the department equipment. This has led to daisy chaining outlet strips, which is not allowed by code.

"Daisy Chained" Outlet Strips

- d. Monitor any circuit shorts to identify any manufacturing defects in insulation.
 - e. Provide missing box and device covers.
 - f. Provide additional circuits and receptacles for high use spaces (Radio Room and Chief's Office).

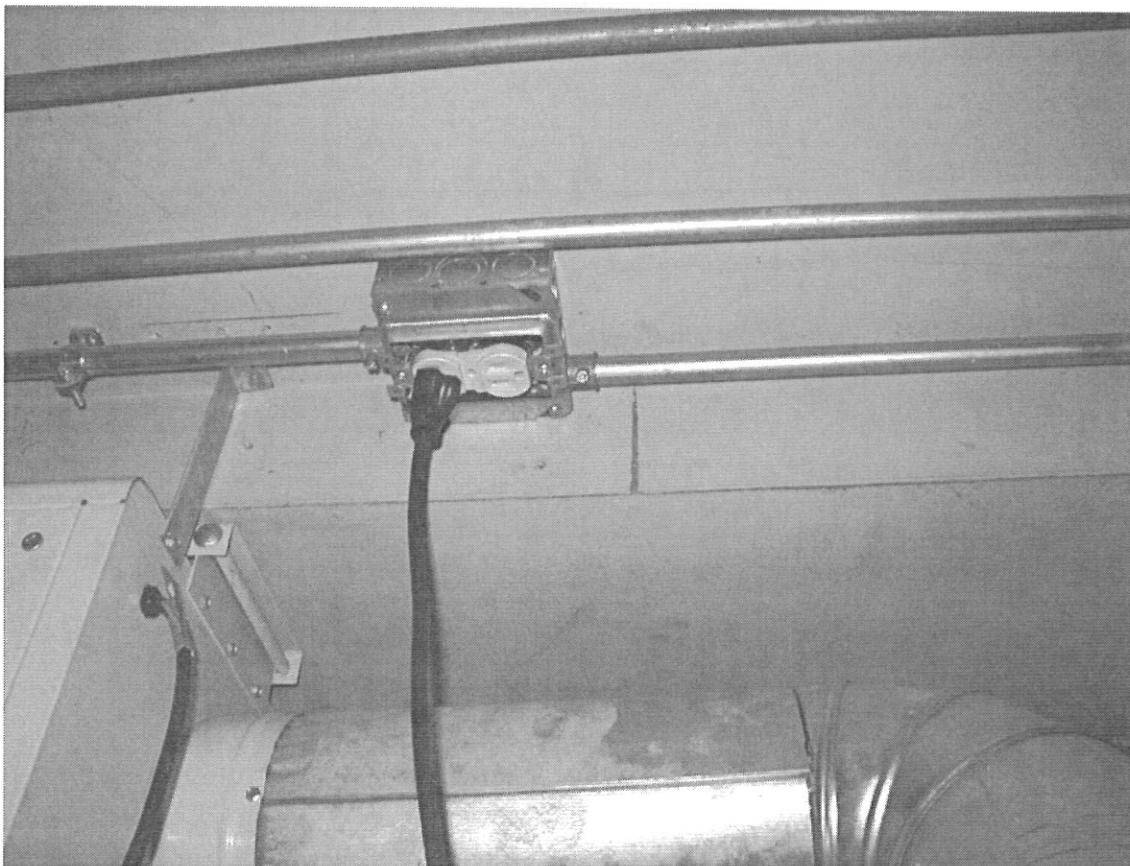
Most boxes had covers, with a few exceptions. Those boxes missing covers will need to have covers installed.

Missing Device Cover Plate

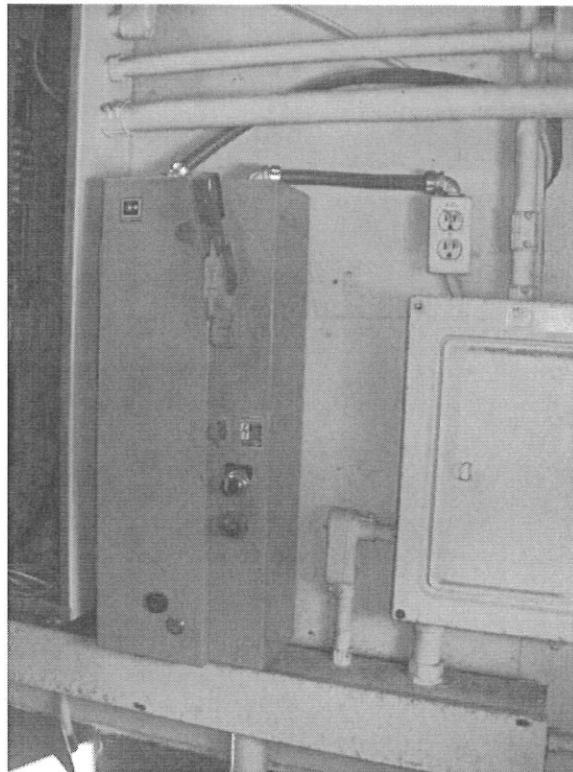
Labeling of devices and circuits is a work in progress. The electrical contractor has been doing an excellent job identifying equipment and circuits as work has been done around the facility. However, there is more identification work to be done.

Combination Motor Starter/Disconnect – Need Labeling

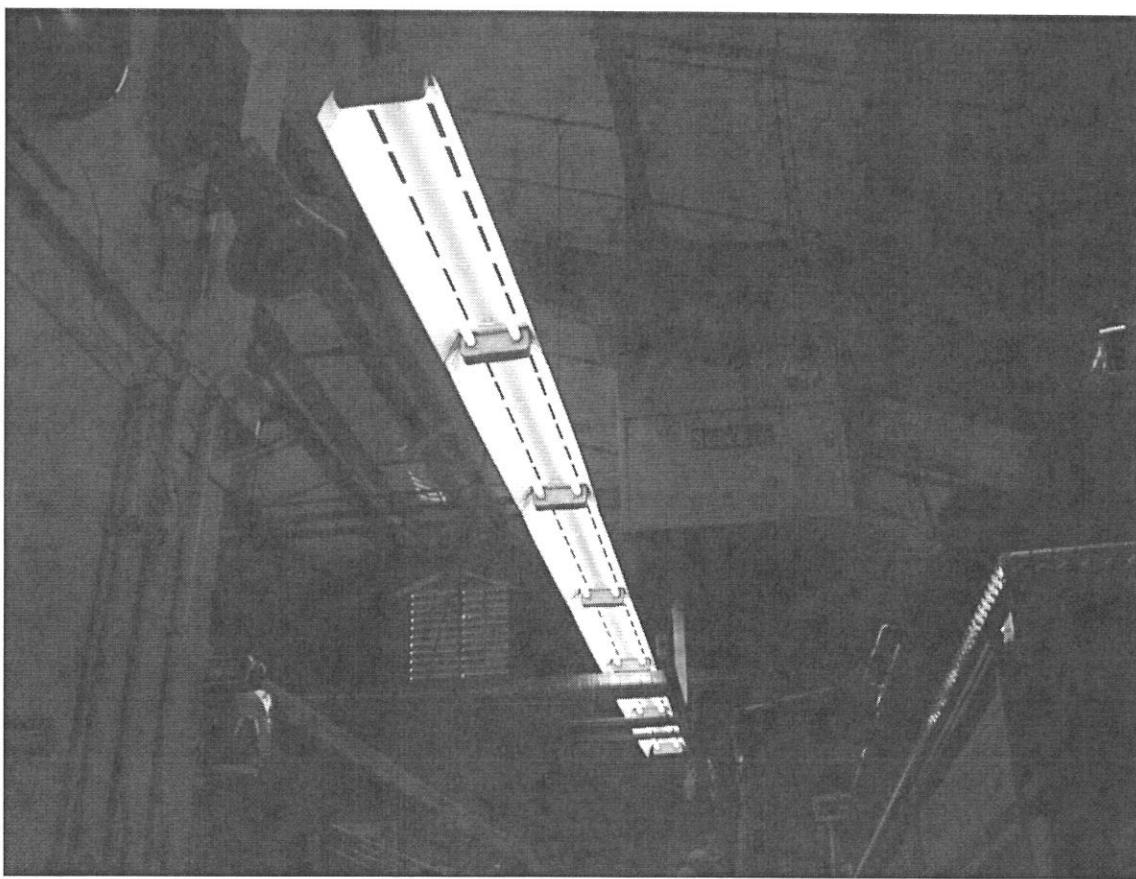
The facility has a mix of fluorescent, metal halide and incandescent fixtures. The original fixtures are near the end of their useful life. As some fixtures fail, fixtures with new technology are being installed. As an example, the suspended, fluorescent T12 fixtures with magnetic ballasts (older technology) in the vehicle bays are being replaced with T8 fluorescents with electronic ballasts as the older fixtures fail.

Vehicle Bay Lighting

- a. Upgrade lighting and lighting controls to meet current energy codes and reduce maintenance costs.
- b. Provide new exterior lighting to meet Dark Sky requirements and to meet the Town of Bow business district requirements.

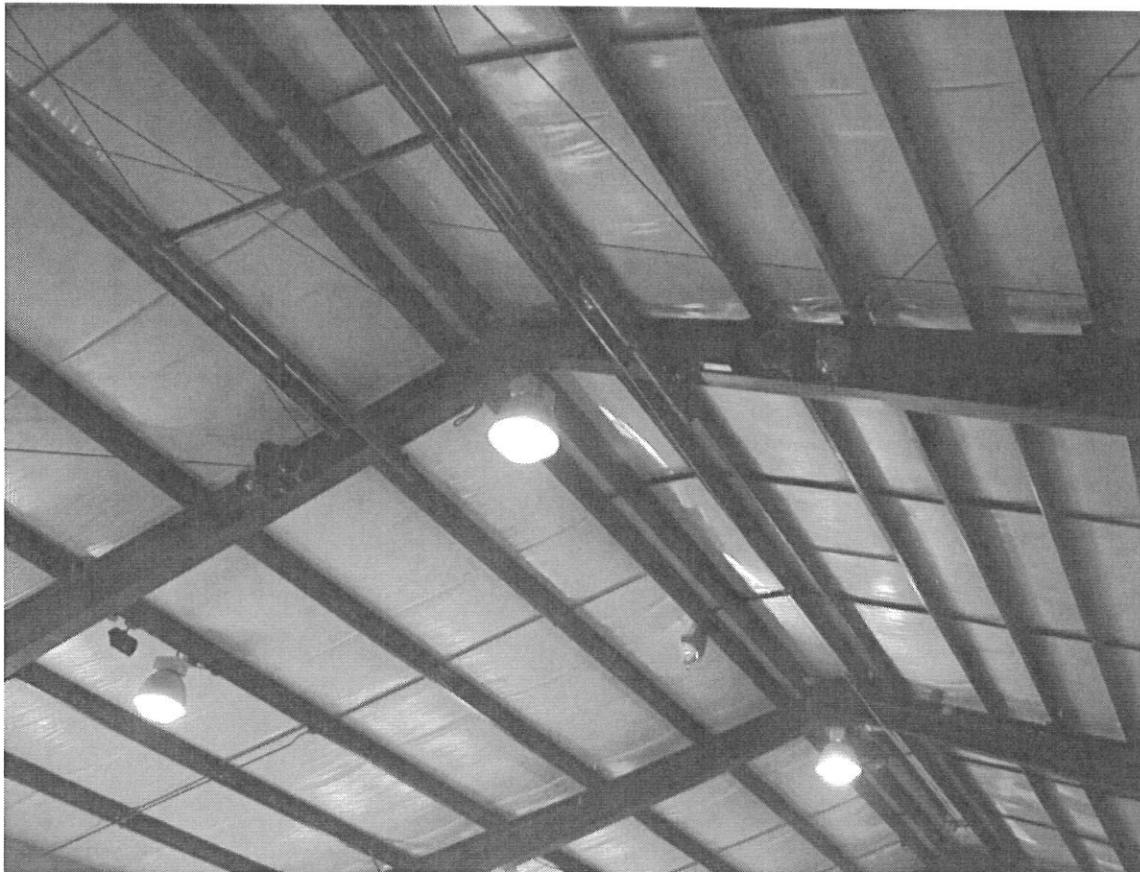
Maintenance has kept up with most light fixtures. There are a couple of non-operating fixtures in the community room and the fan/light kit in women's restroom off the community room is not operational.

Interior lighting is controlled by manual switches. Interior lighting controls do not meet current energy code requirements for automatic shutoff of lights or additional controls for areas with available daylight. New lighting controls can provide an opportunity to increase lighting energy efficiency.

Multi-Purpose Community Room Lighting

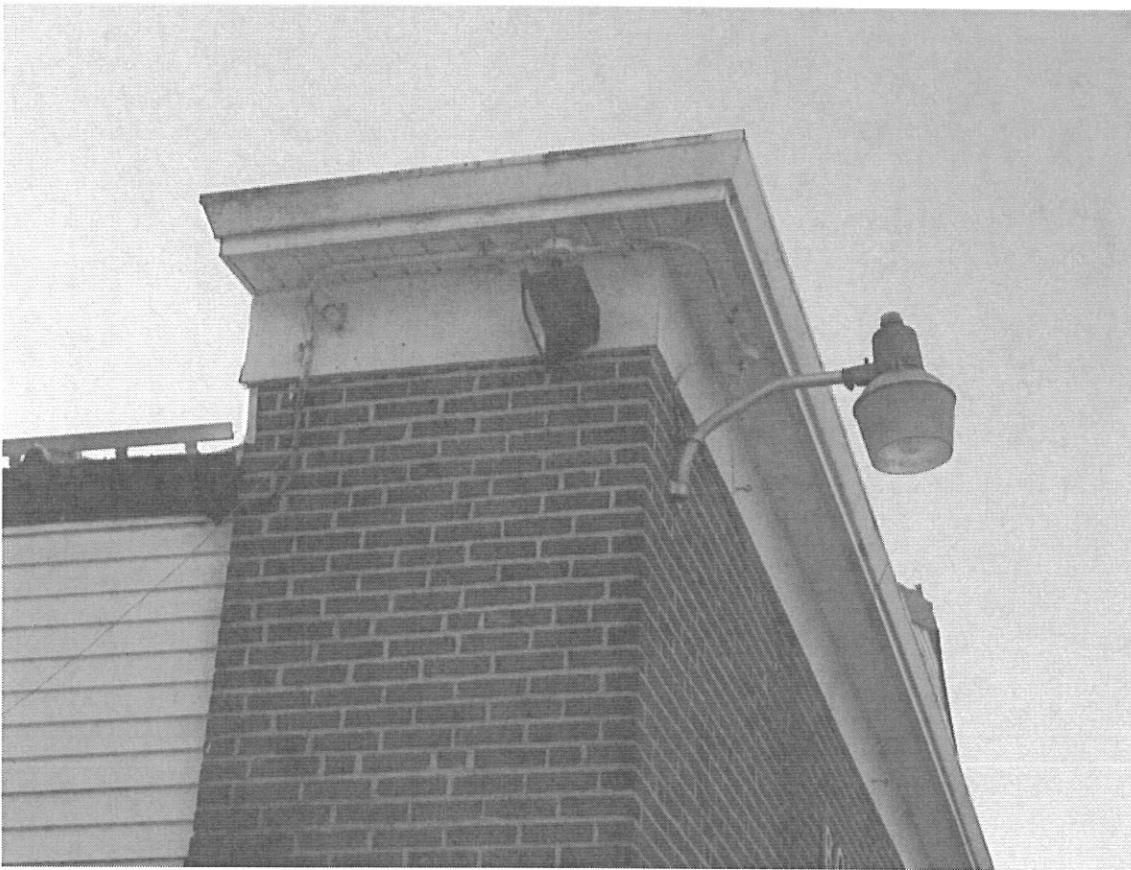
Exterior lighting is predominately HID (High Intensity Discharge) area lights and flood lights. The exterior fixtures are not Dark Sky compliant. The Town of Bow ordinances do not require Dark Sky compliance; however, the flood light fixtures would not meet the Performance Standard Sections in the Business Development District Requirements with regard to bare bulbs in view of adjacent property or public right-of-way.

Exterior Yard Light and Flood Light

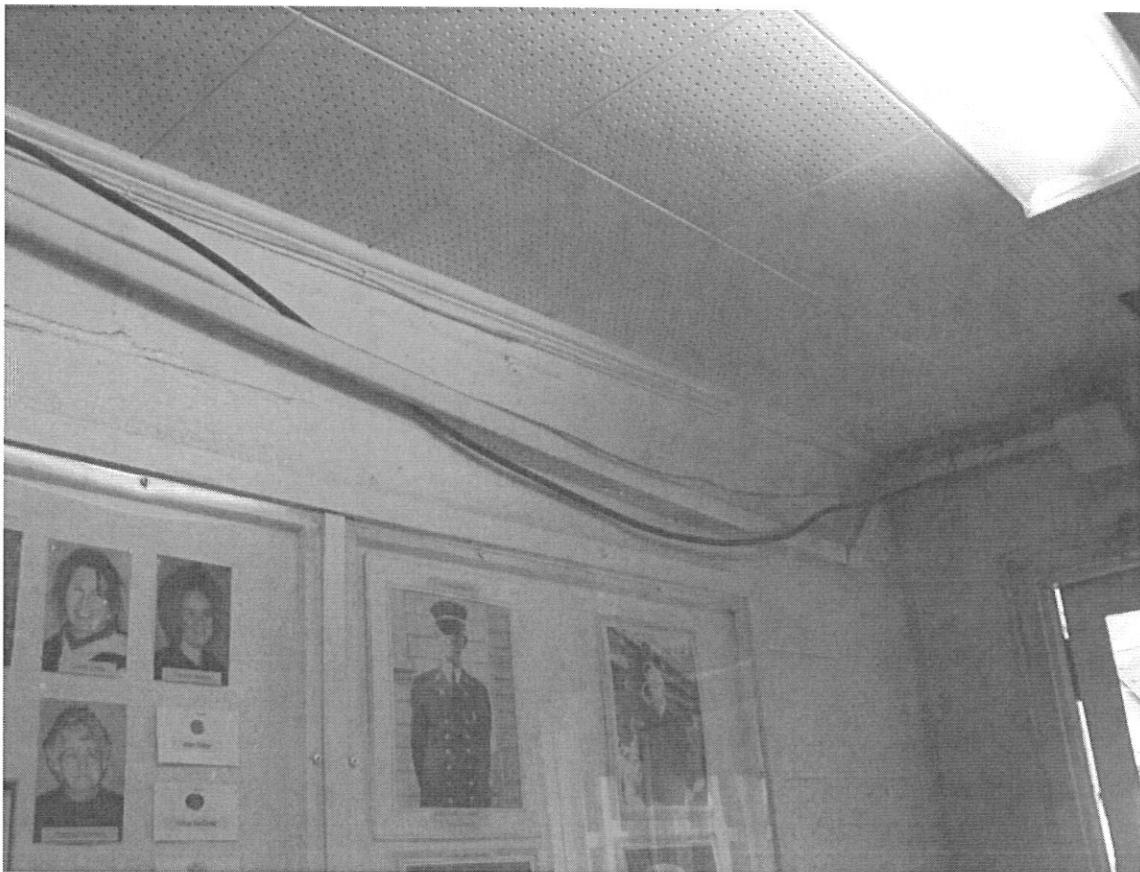
Telecom pathways have support deficiencies.

Telecom Pathways Improperly Supported

- a. Provide proper support for telecom cables and raceways.
- b. Provide dedicated spaces for telecom systems.

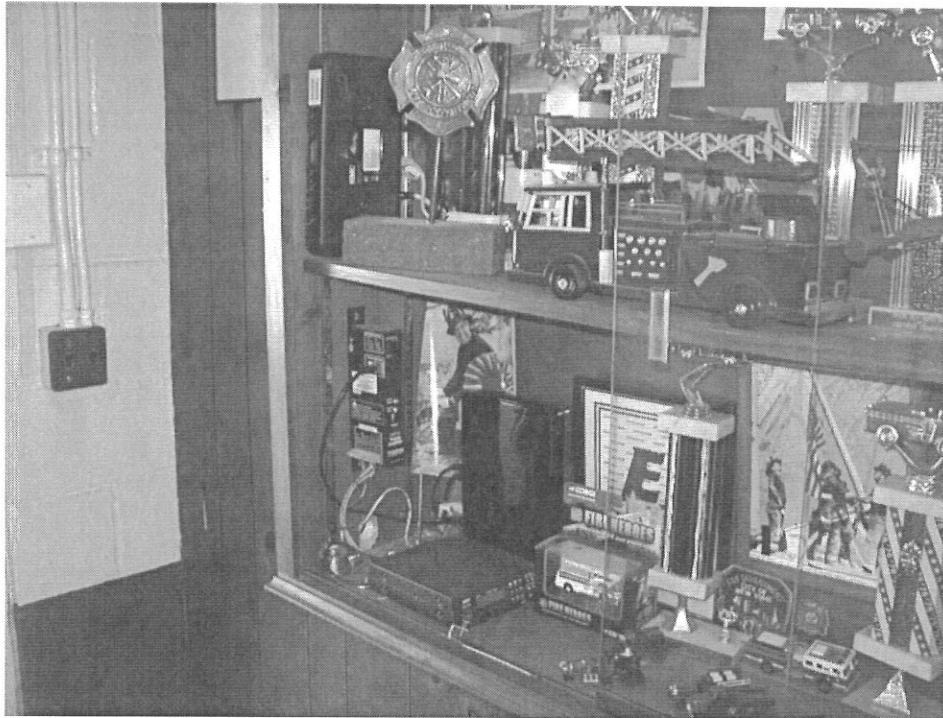
Networking Equipment

Ideally, networking equipment should be in dedicated spaces. Given the limitation of free space as well as the recognition that modern networking needs were not part of the building's original design, networking equipment has been placed in areas that could pose challenging if the fire station were required to be a command post during a major incident or crisis.
