BOW SAFTEY SERVICES BUILDINGS

Structural Observation

June 14, 2006

Re: Structural Observation
Bow Safety Complex
OSE project: 06-121

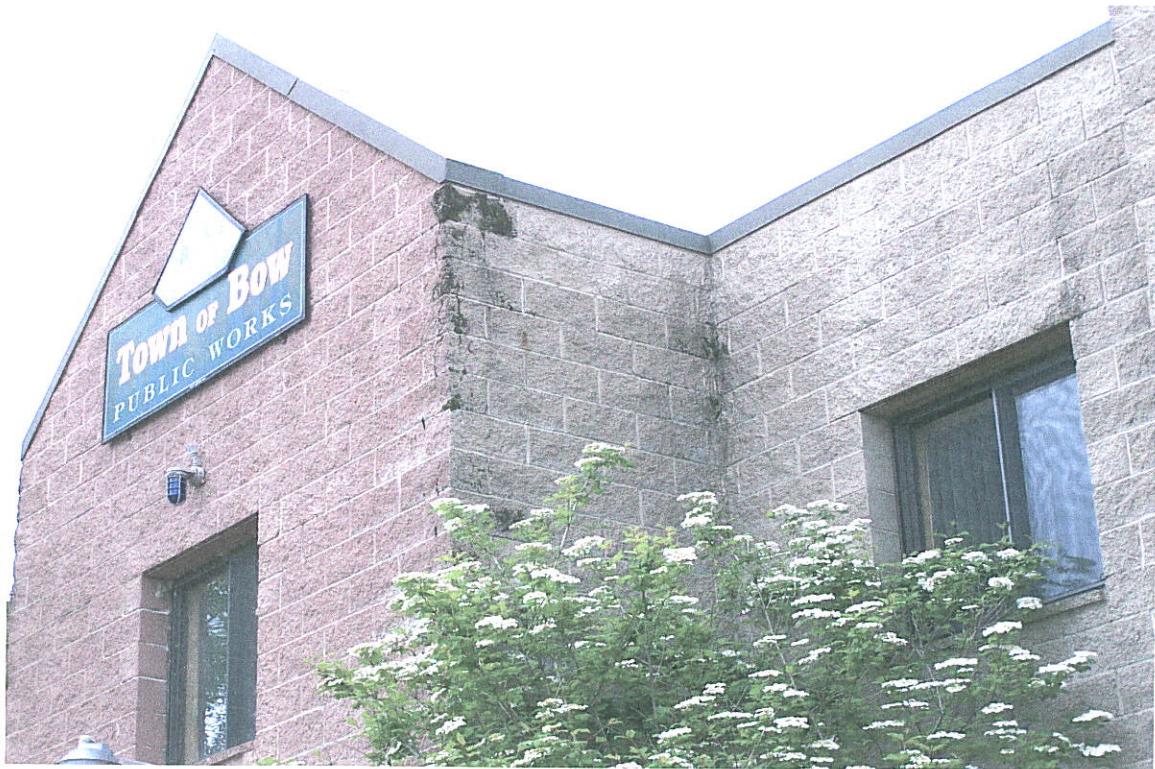
4. Efflorescence and mold were noted on the wall of the Police Station. Other evidences of water penetration were also noted during the walk through. Although, by

themselves, these are not necessarily structural issues; the source of the water needs to be determined and corrected, if necessary, in order to prevent any structural damage in the future.

1. Police Station, Note: water stains and efflorescence

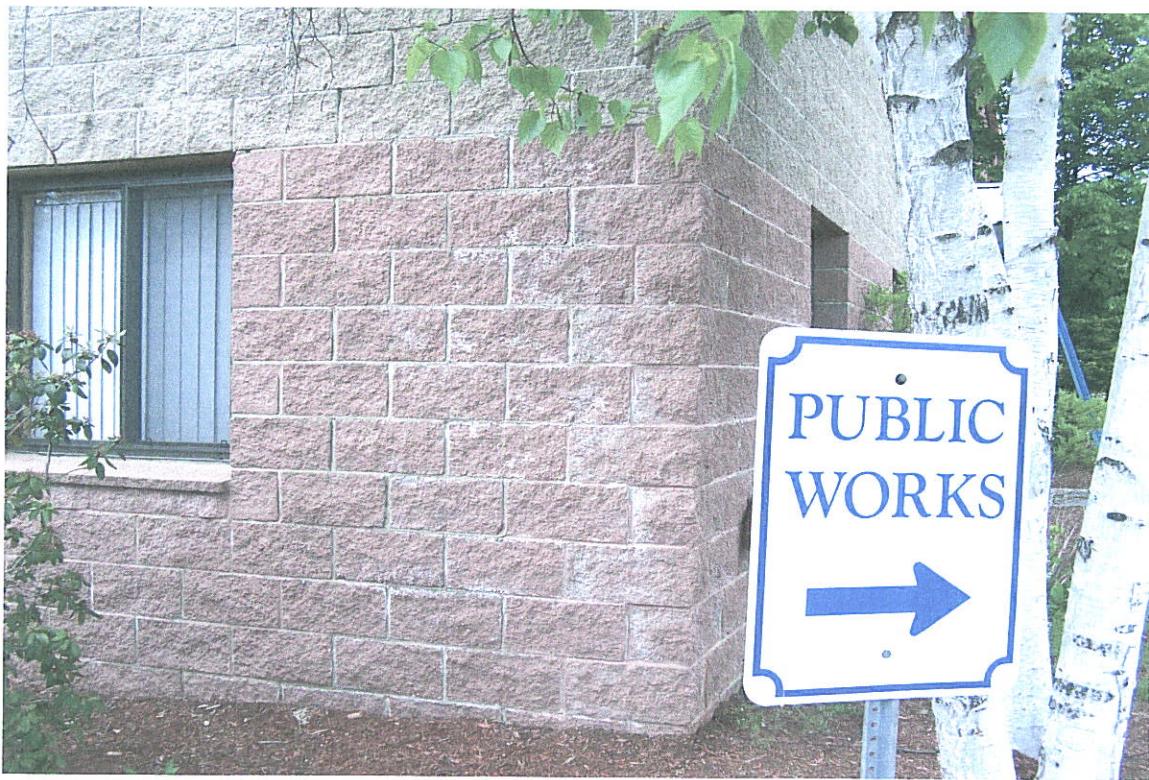
2. Police Station, Note: efflorescence

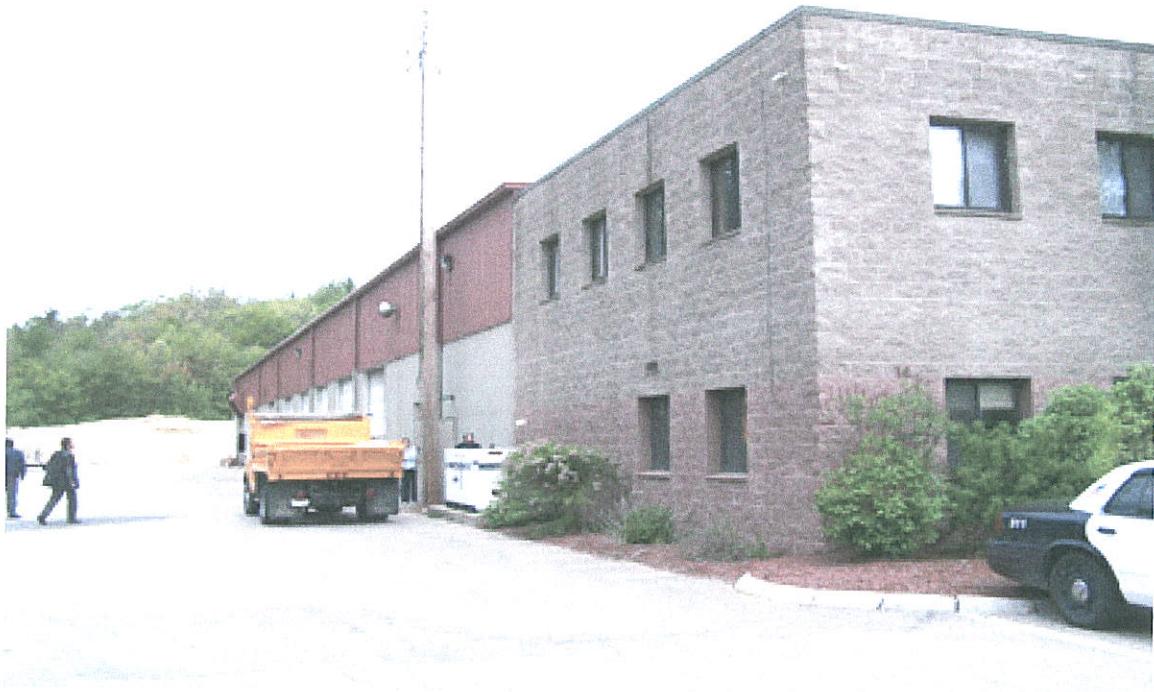
3. Police Station and Town Garage Building

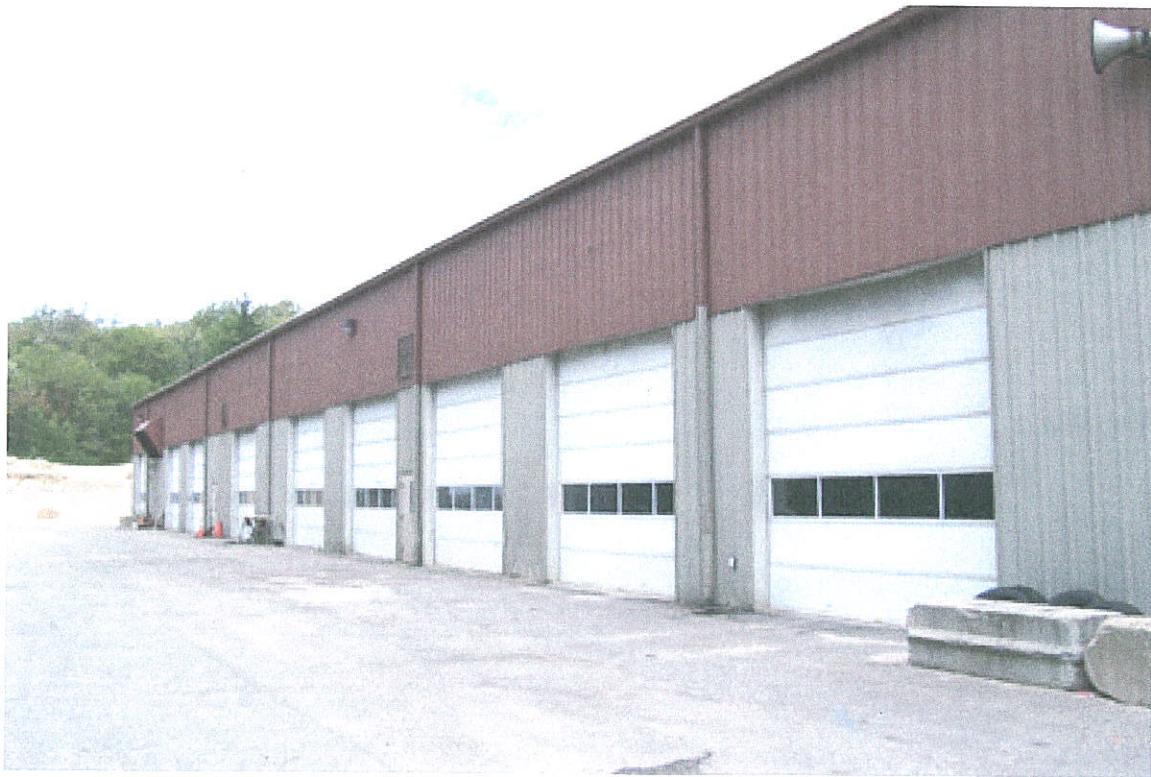
4. Town Garage

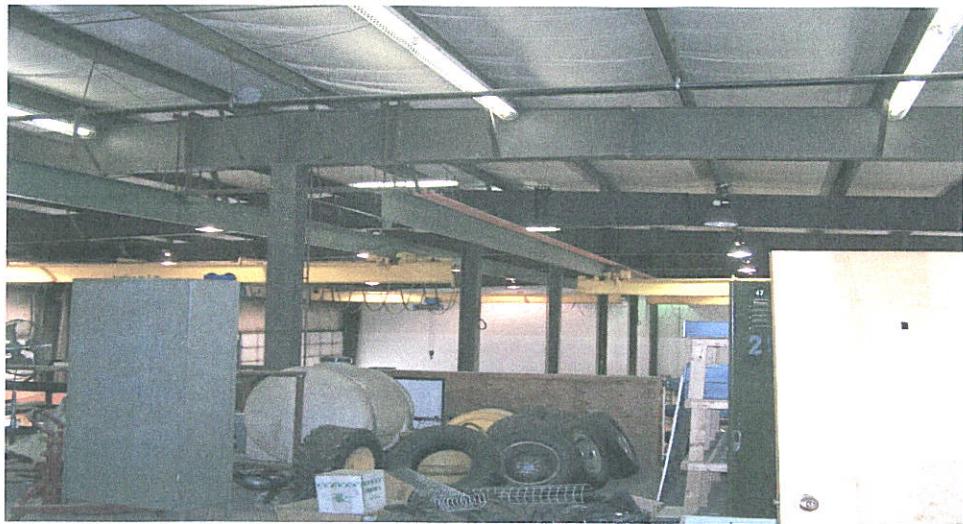
5. Town Garage Interior

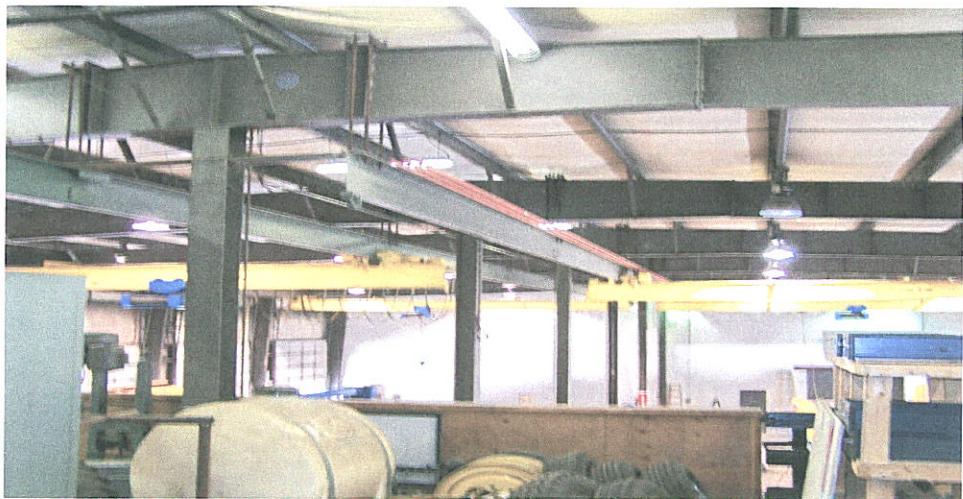
6. Town Garage Interior

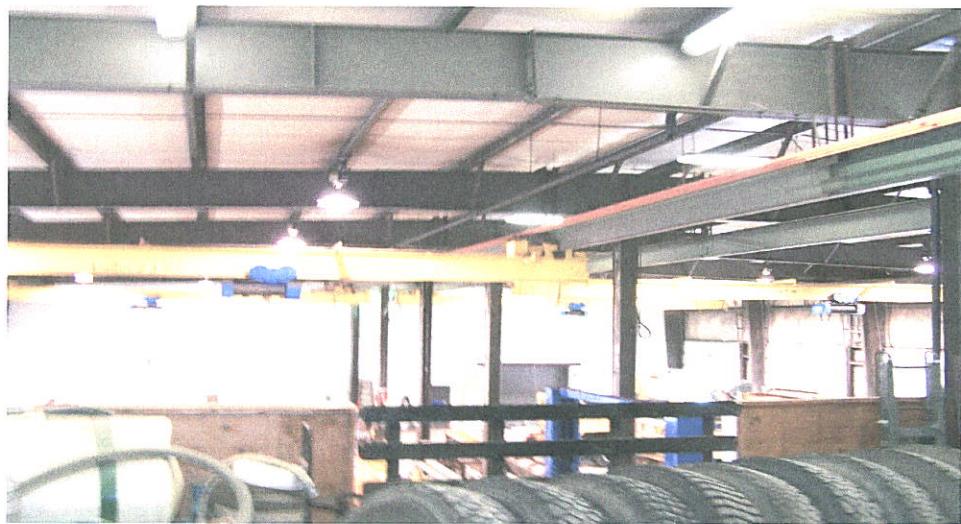
7. Town Garage Interior

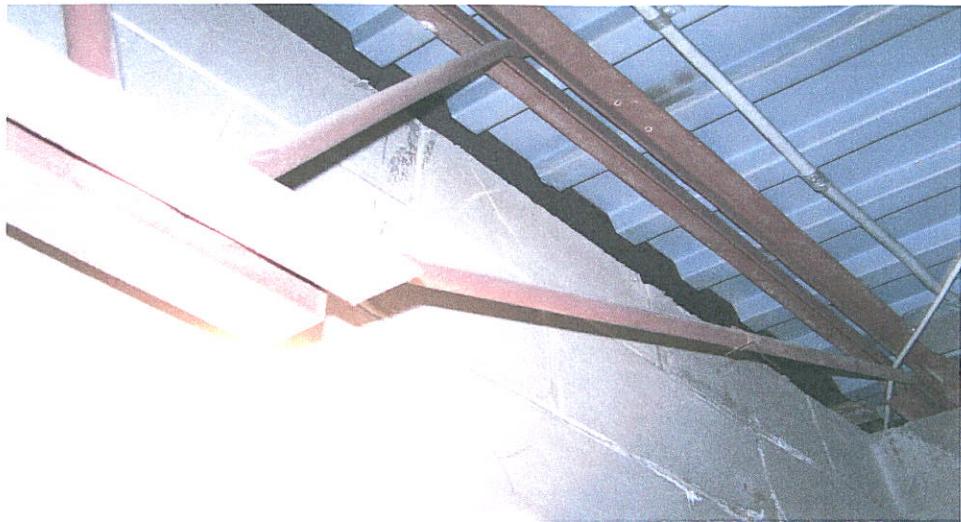
2. In one location in the police building, the removal of a ceiling panel revealed the roof diaphragm connections to the CMU wall were absent (pictures 8 thru10). These connections are important in the performance of the building during a wind or seismic event and can compromise the post disaster functionality. As part of a detailed structural review, these conditions should be investigated and, if necessary, corrected.

8. Interior Police Dept. Note: lack of diaphragm connection to wall.

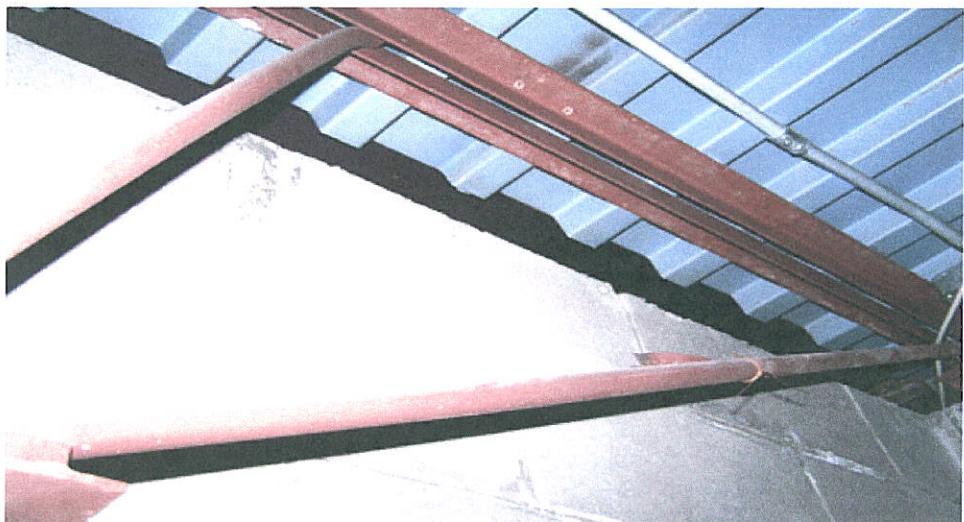
9. Interior Police Dept. Note: lack of diaphragm connection to wall.

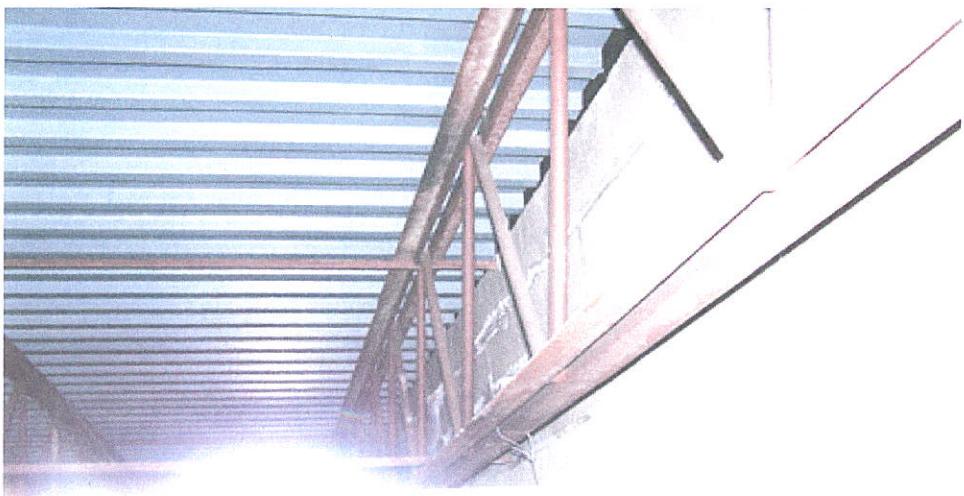
10. Interior Police Dept. Note: lack of diaphragm connection to wall.

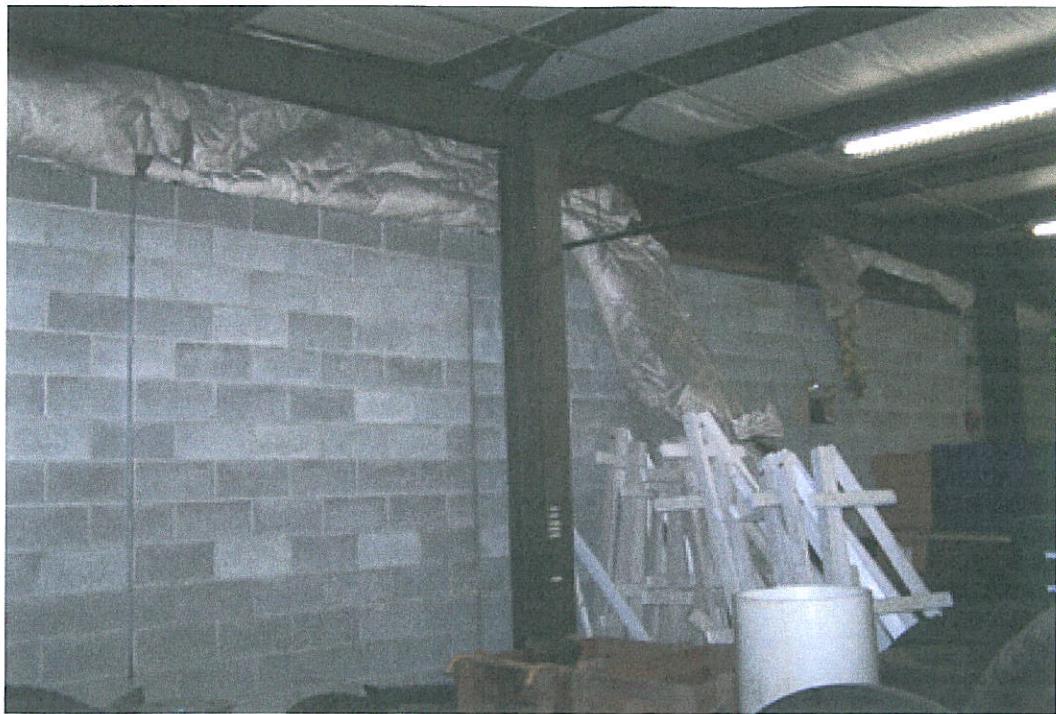
11. Police Building standing on Mezzanine looking at wall of station

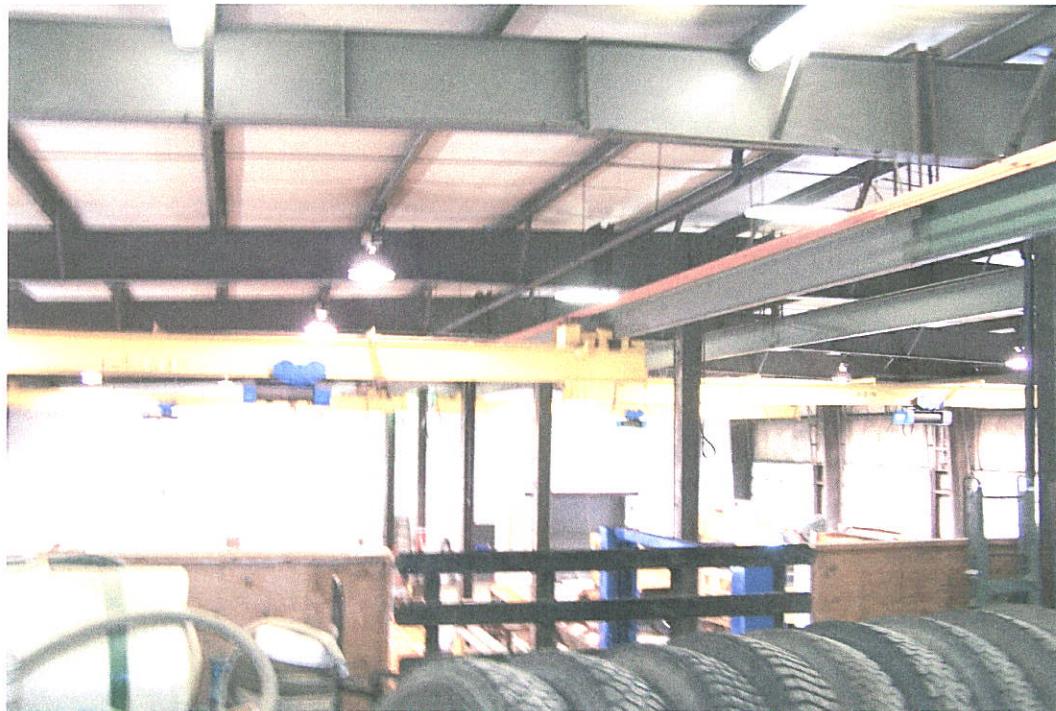
12. Police Building, standing, on Mezzanine looking into garage

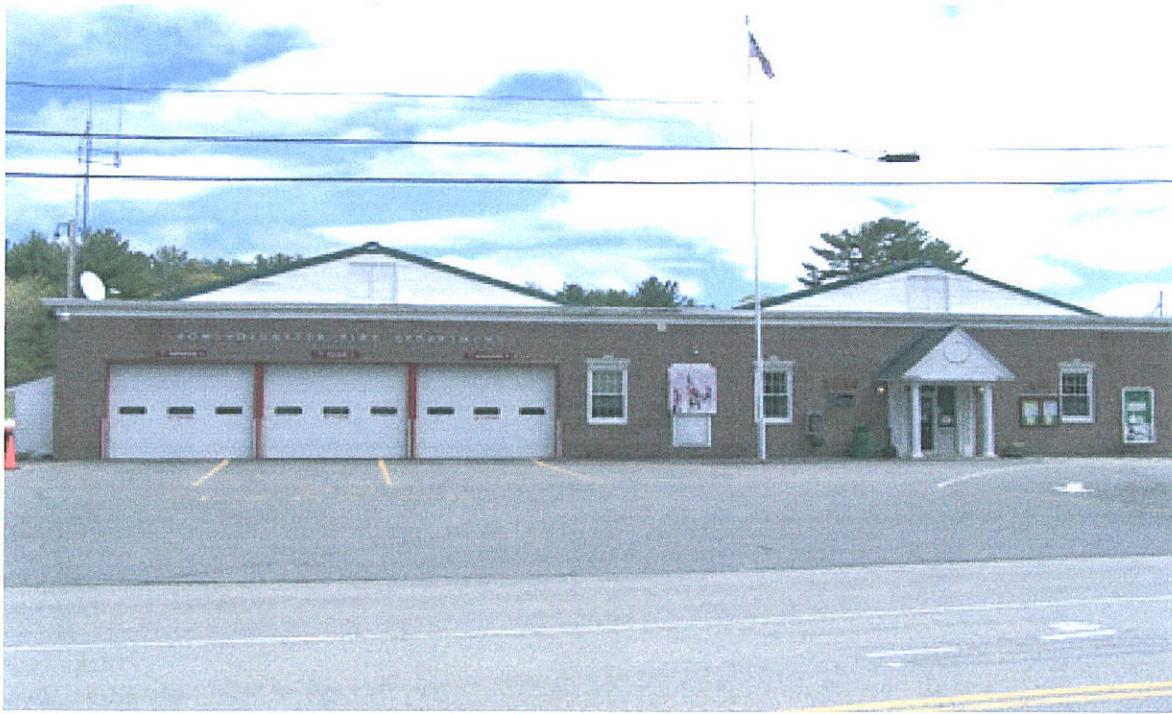
13. Bow Fire Station, front elevation

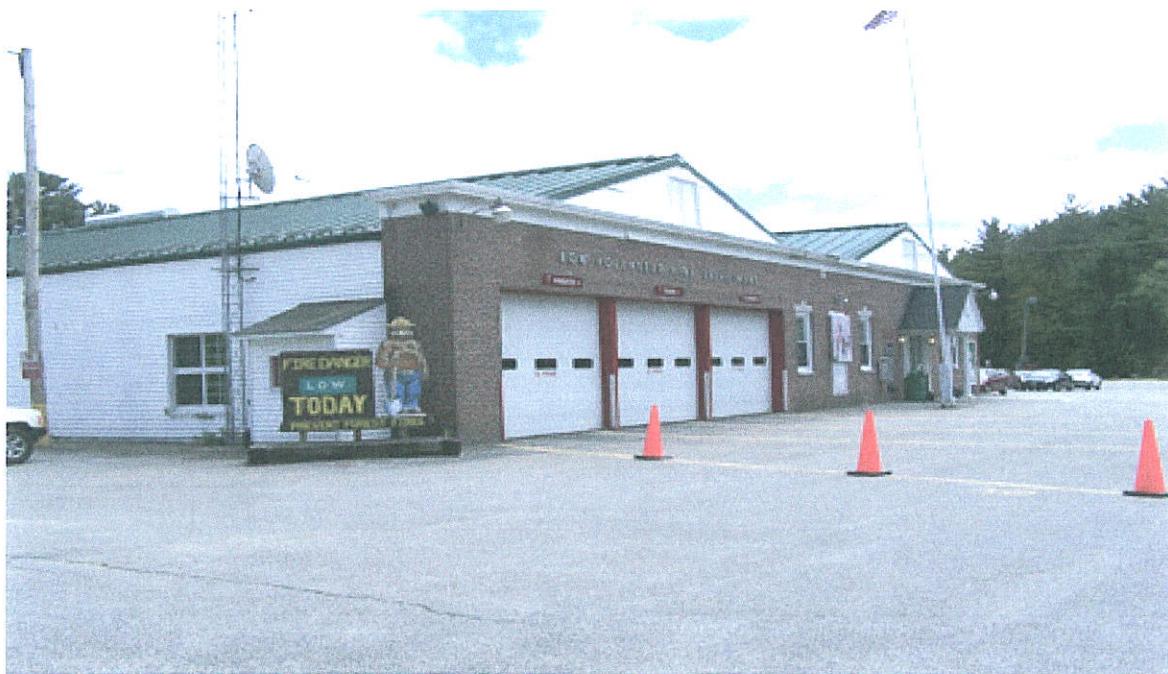
14. Bow Fire Station showing the two gable roofs

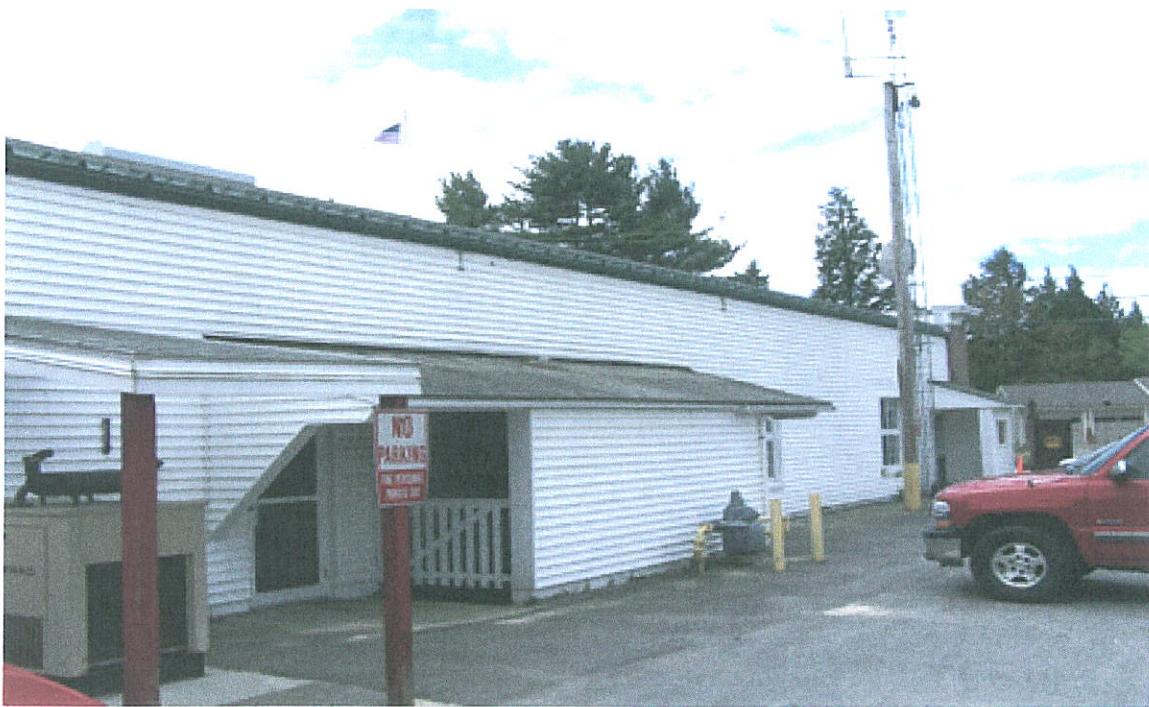
15. Bow Fire Department, side elevation looking toward the front.

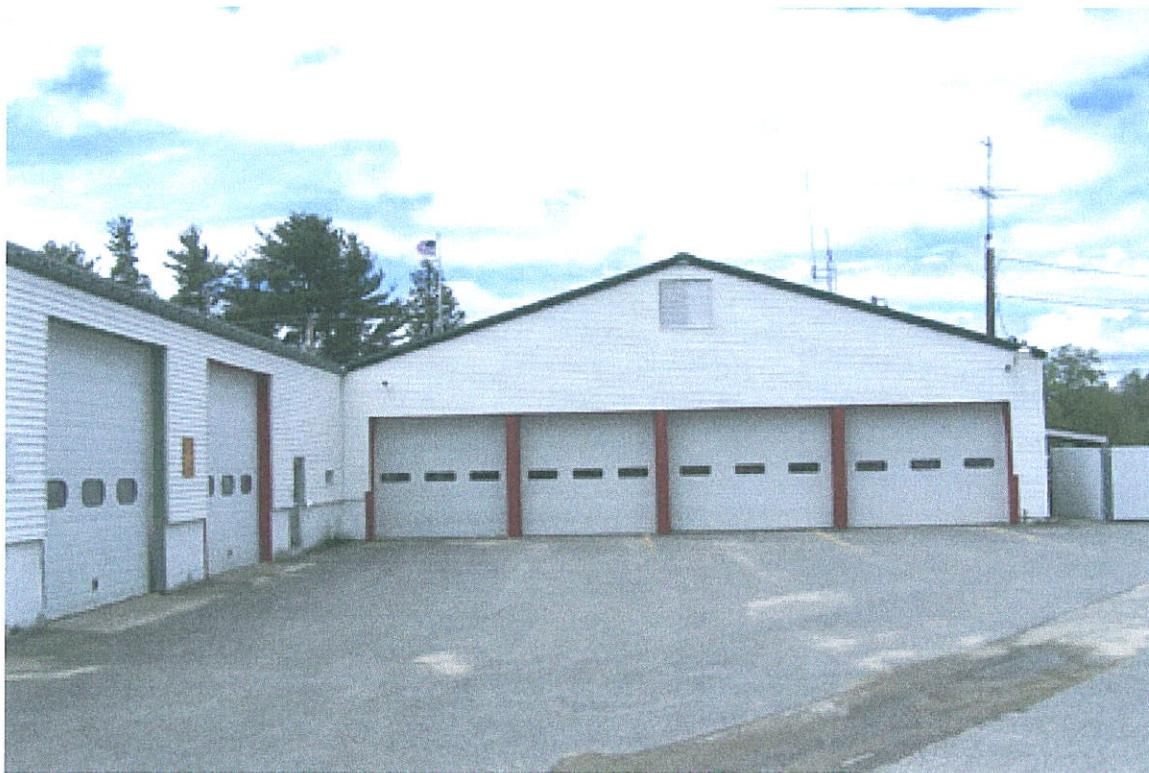
16. Bow Fire Department, rear elevation

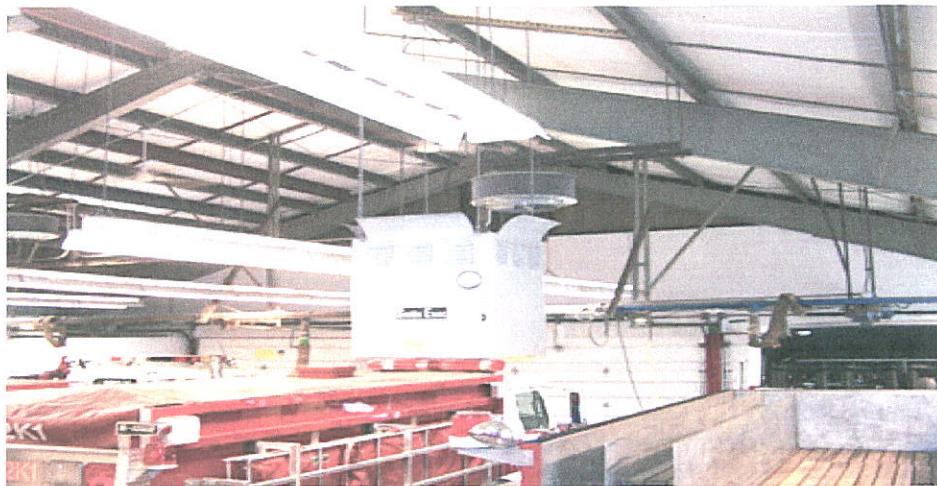
17. Fire Department Interior

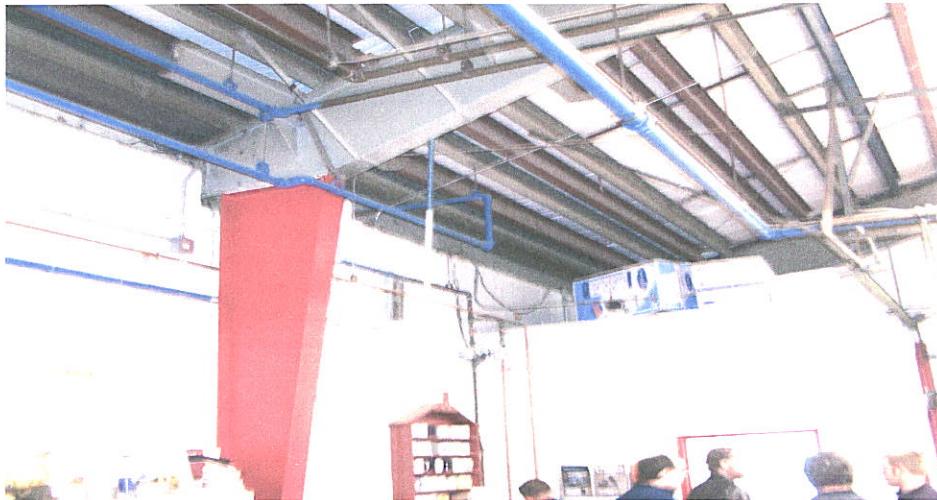
18. Fire Department Interior

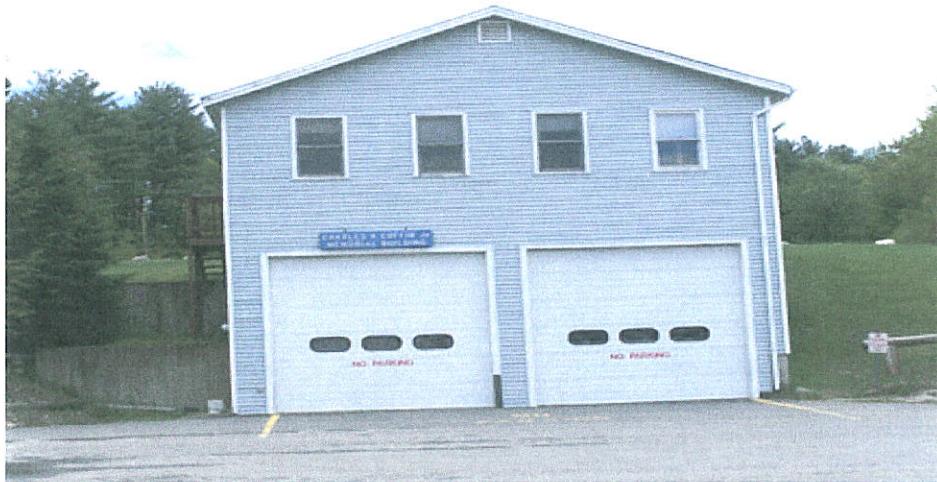
5. One face of the smaller building used by the Fire Department appears to have insufficient lateral load resisting elements (shear walls, etc.)(Picture 19). The lateral adequacy of the walls is important to post disaster functionality. This condition should be reviewed and corrected if necessary
6. Unrestrained objects shifting or equipment collapse may cause harm to occupants and impose hardship during an event and can also affect post functionality of a department. To prevent this circumstance, a thorough evaluation of the stability and the connections of each departments' equipment and contents should be part of the recommended review.

19. Bow Fire Dept., smaller building, Note: apparent lack of shear wall.

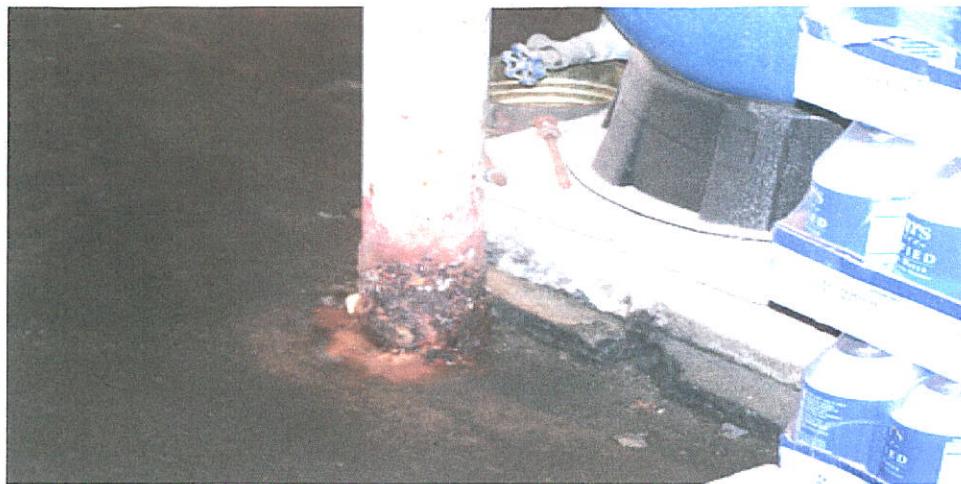
1. Rusted columns were observed in the basement of the Fire Station Building (pictures 20 and 21). Standing water was observed in the basement at the time of this walk through, and it appears that the basement has been regularly flooded with water. These columns need immediate attention and repair to prevent any structural compromise of the framing.

20. Rusted basement column, Fire Department

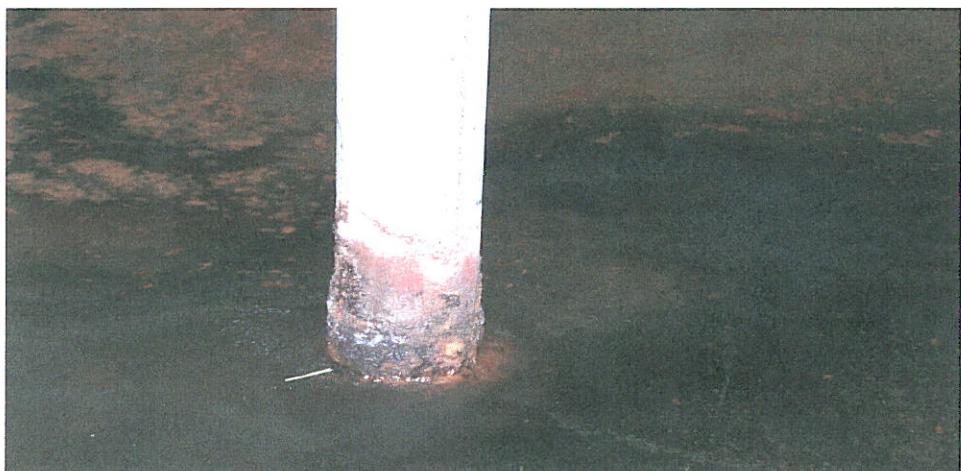
21. Rusted basement column Fire Department
