Town of Bow Fire Station/Community Building Electrical Assessment
October 7, 2013

YEATON ASSOCIATES, INC.

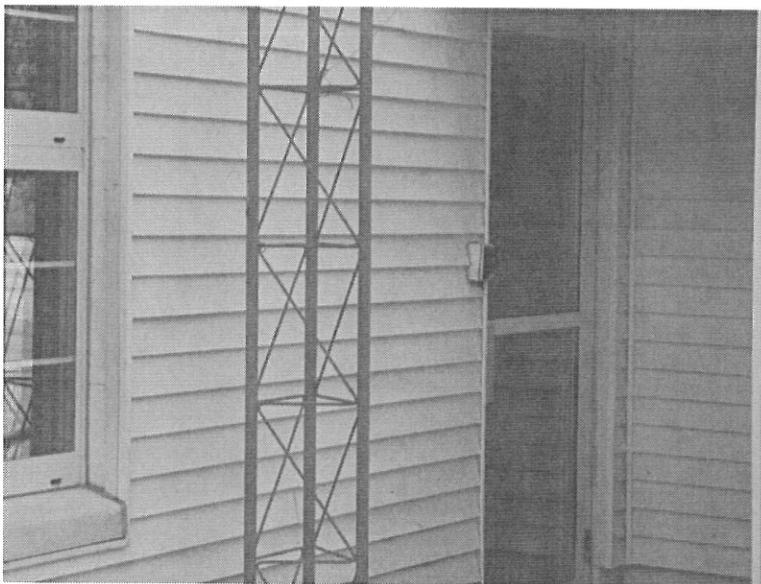
The Fire Station has a door access control system with proximity card readers at entry doors.

Entry Door with Proximity Card Reader

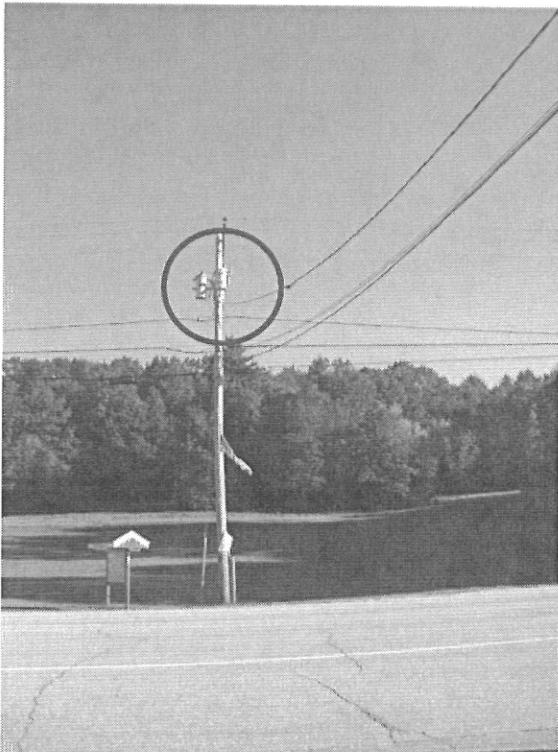
The overhead utility service extends to a power pole, adjacent to Bow Fire Station, and on to an exterior service disconnect and meter.

Pole Mounted Unitil Transformers North Side Knox Road

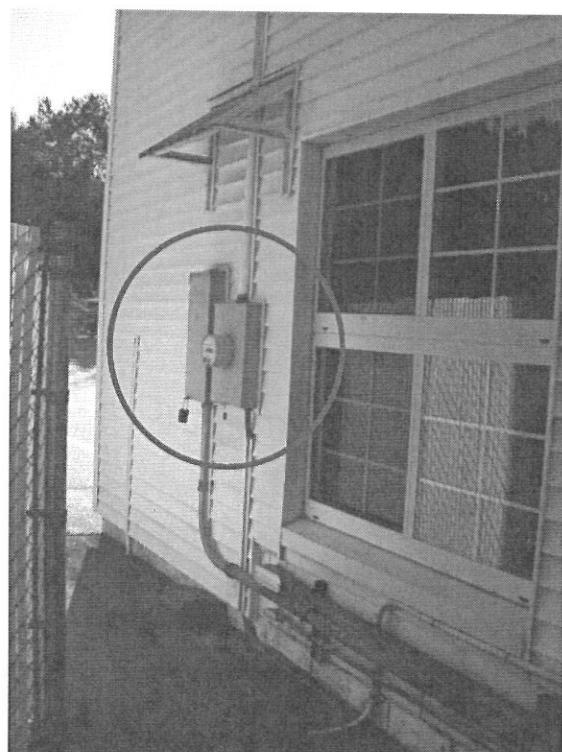
The electric service is 120/208, 3-phase, with a 225 amp main breaker in the Main Panel. There are nine load centers distributing power through the facility. Existing electric demand, provided by Unitil, is 27.9 KW, or about 92 amps based on an assumed 0.85 power factor. There is no surge protection on the service entrance.

Service Entrance Disconnect and Meter

1. Electrical Service: The existing service is adequate for current use of the building. Currently, there are no recommendations with regard to the electrical service, unless significant loads are added to the building such as central air conditioning or a commercial kitchen is added to the building.

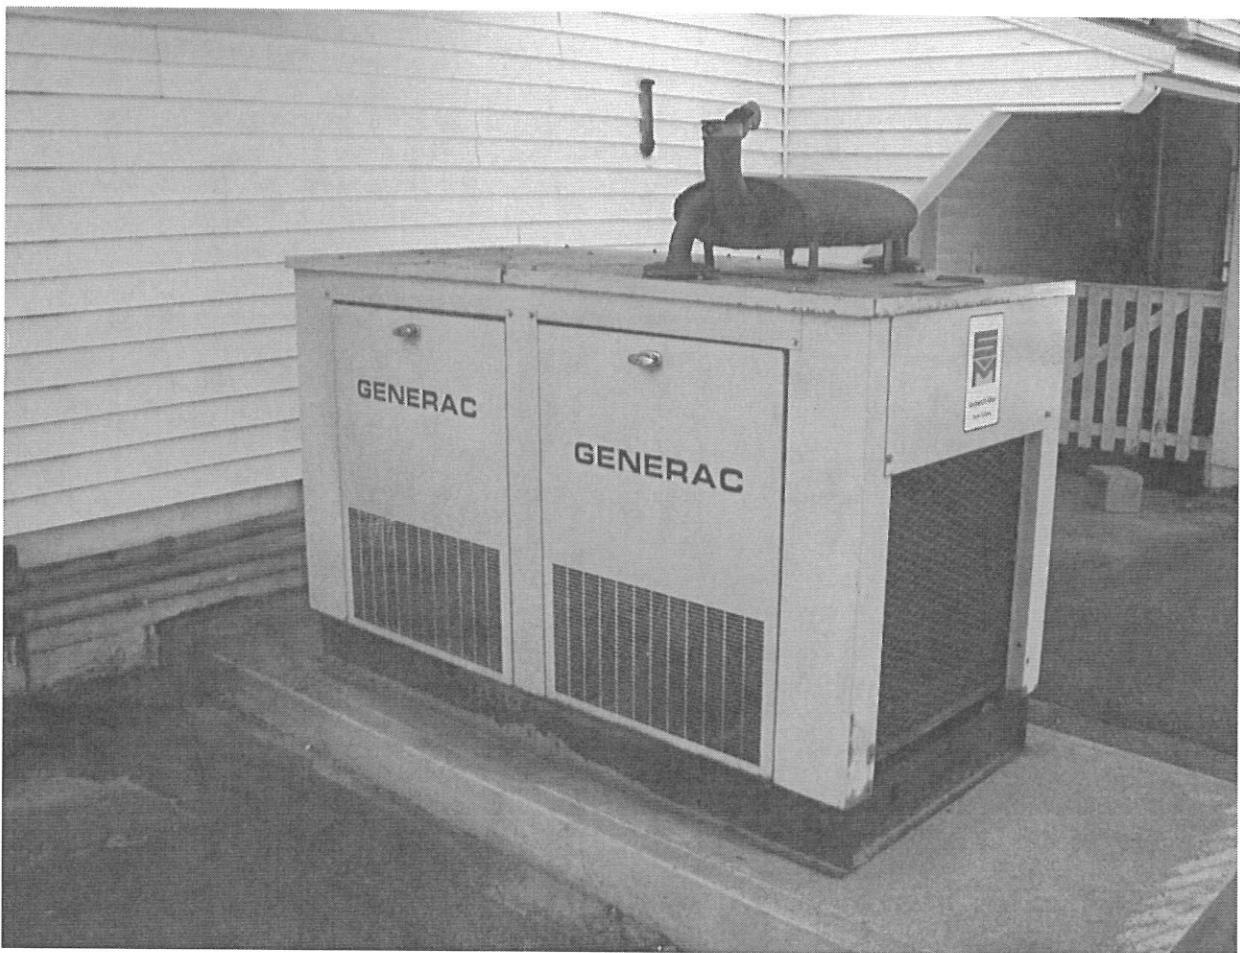
The building electrical service is backed-up by a 30 KW/37.5 KVA, diesel generator. The generator is located exterior to the building on the north side. It has a weatherproof enclosure and additional protection by a shed roof. The fuel tank is located inside in the closest vehicle bay.

The generator is tested weekly, and there are no known maintenance issues.

30 KW Standby Generator

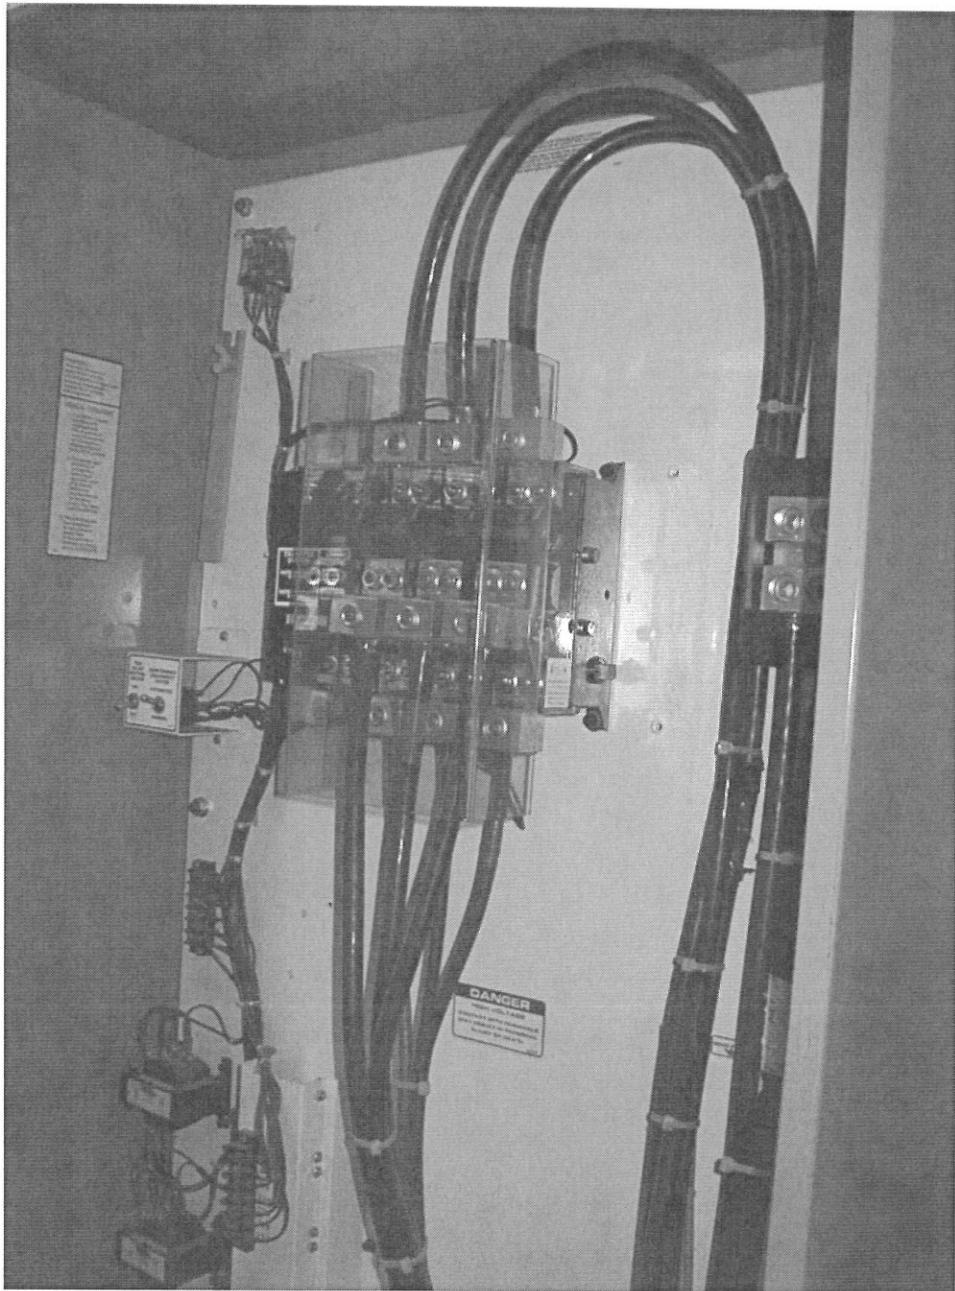
Power from the generator is transferred through a 3-pole, Generac MTS transfer switch. The generator has its own supplemental ground rod. More discussion of the grounding can be found under "Grounding" below.

Automatic Transfer Switch, 3-pole

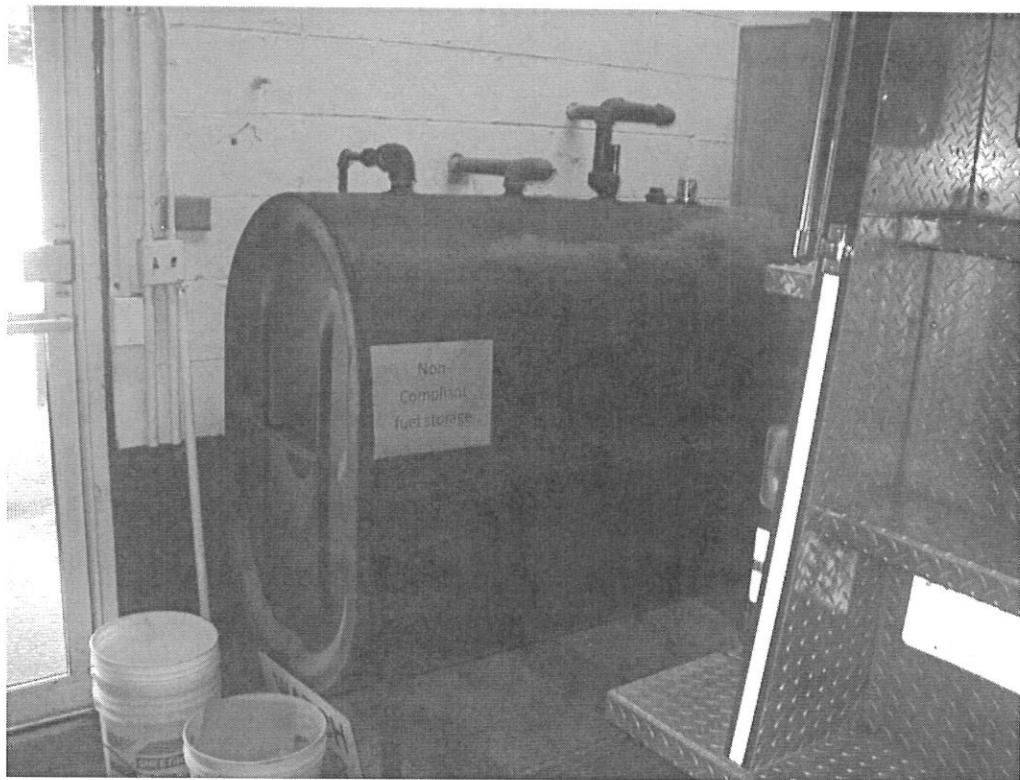
Standby Generator Fuel Tank in Vehicle Bay

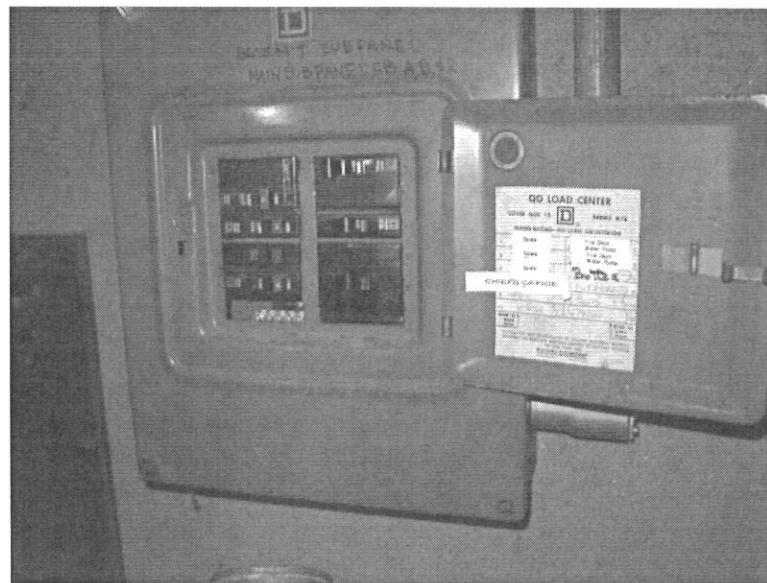
Note the New Labeling and Identification of Source Panel

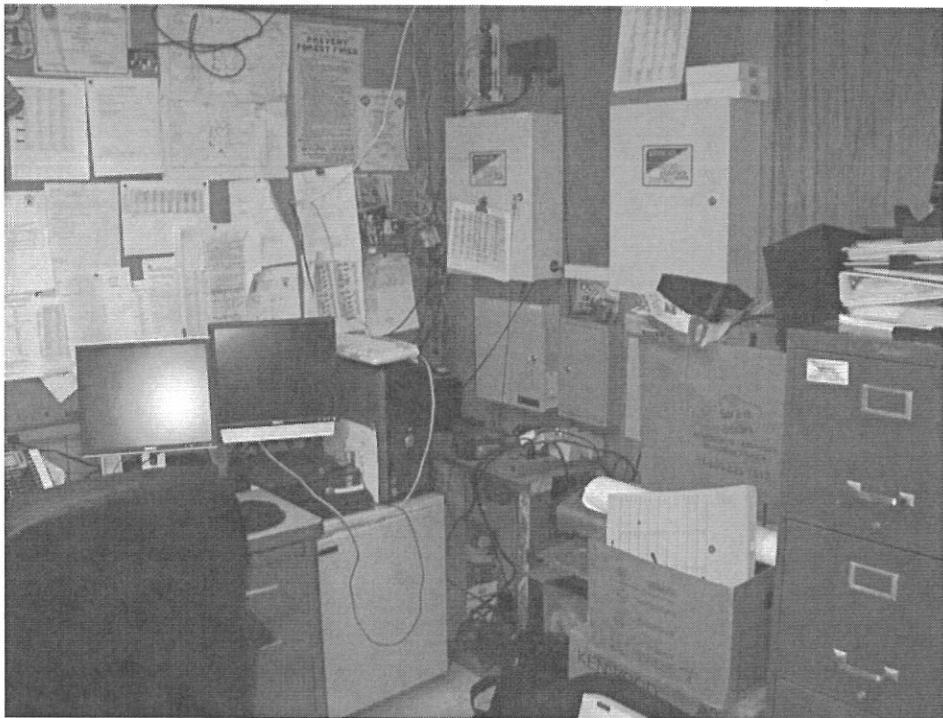
Ideally, networking equipment should be in dedicated spaces. Given the limitation of free space as well as the recognition that modern networking needs were not part of the building's original design, networking equipment has been placed in areas that could pose challenging if the fire station were required to be a command post during a major incident or crisis.

Active Telecom Demarcation in Chief's Office
